ATTACHMENT A**LIMITED RENOVATION ASBESTOS SURVEY REPORT**

**Communicore – Air Handlers 7 & 8 Replacement
University of Florida
Gainesville, Florida**

GLE Project No.: 20140-01875

January 2020

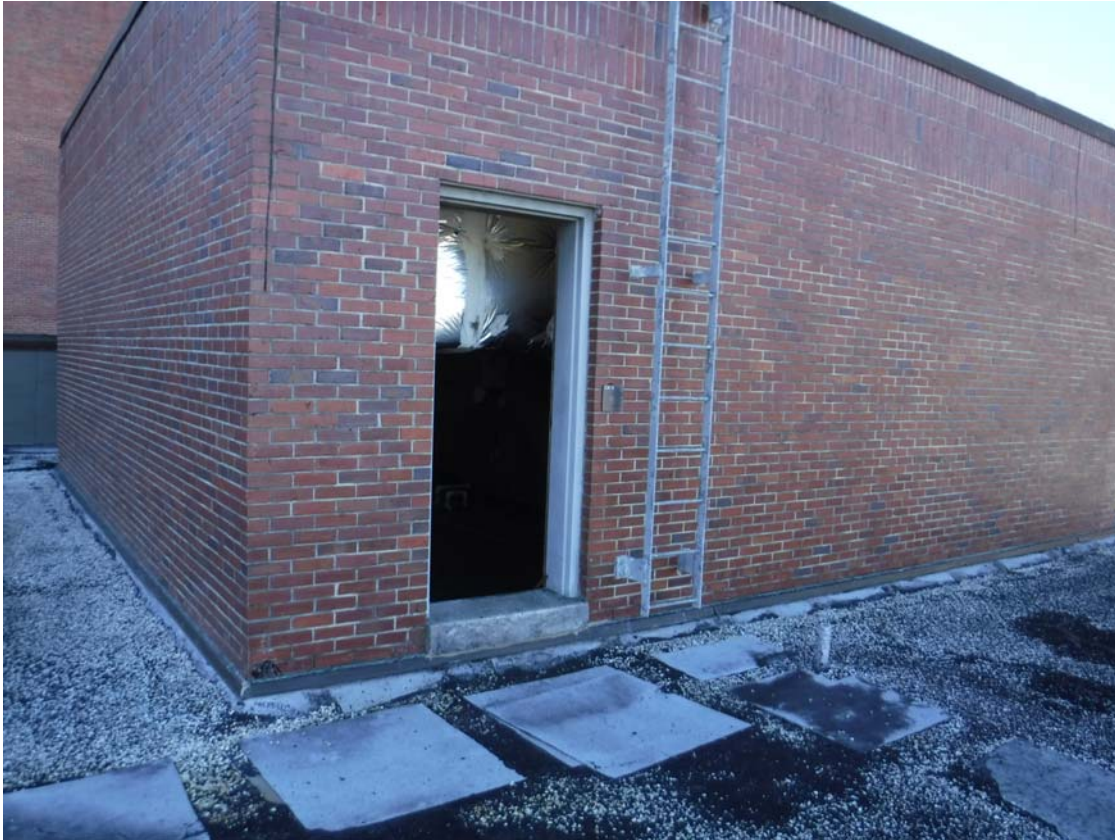
Upper Photo: Exterior View of C4-3

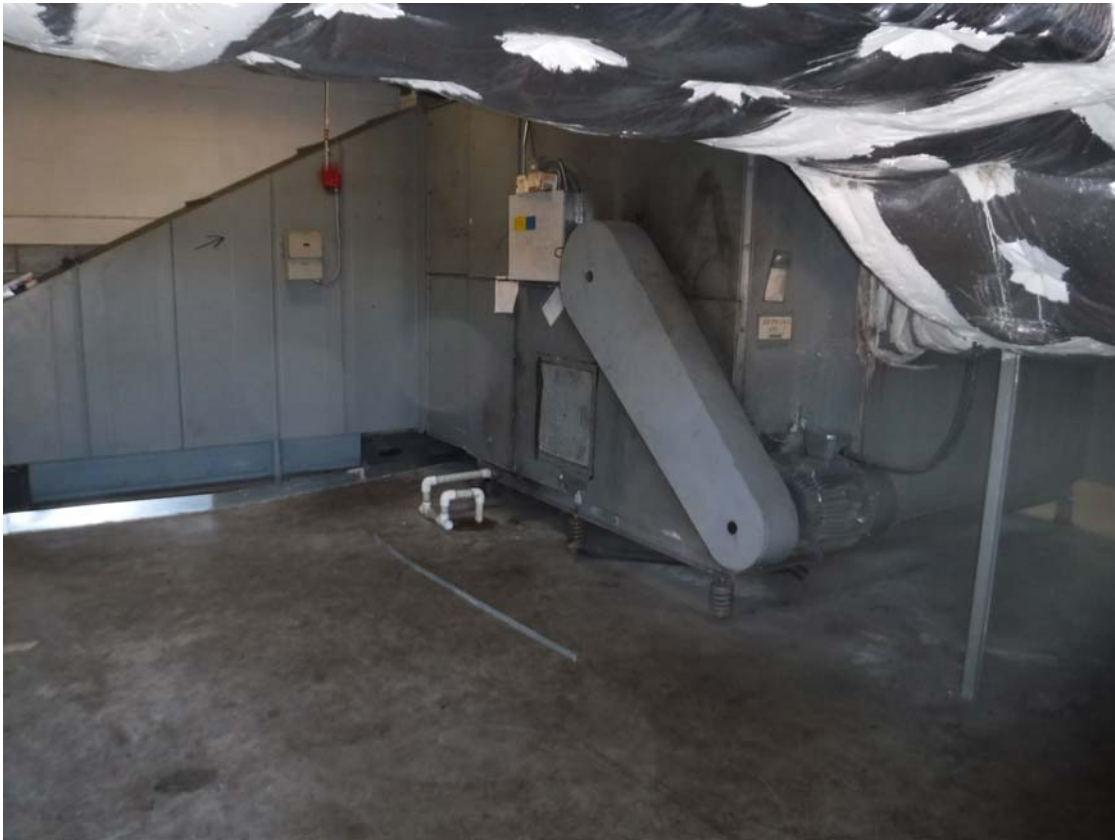
Lower Photo: Interior View of C4-3 (AHU 7)

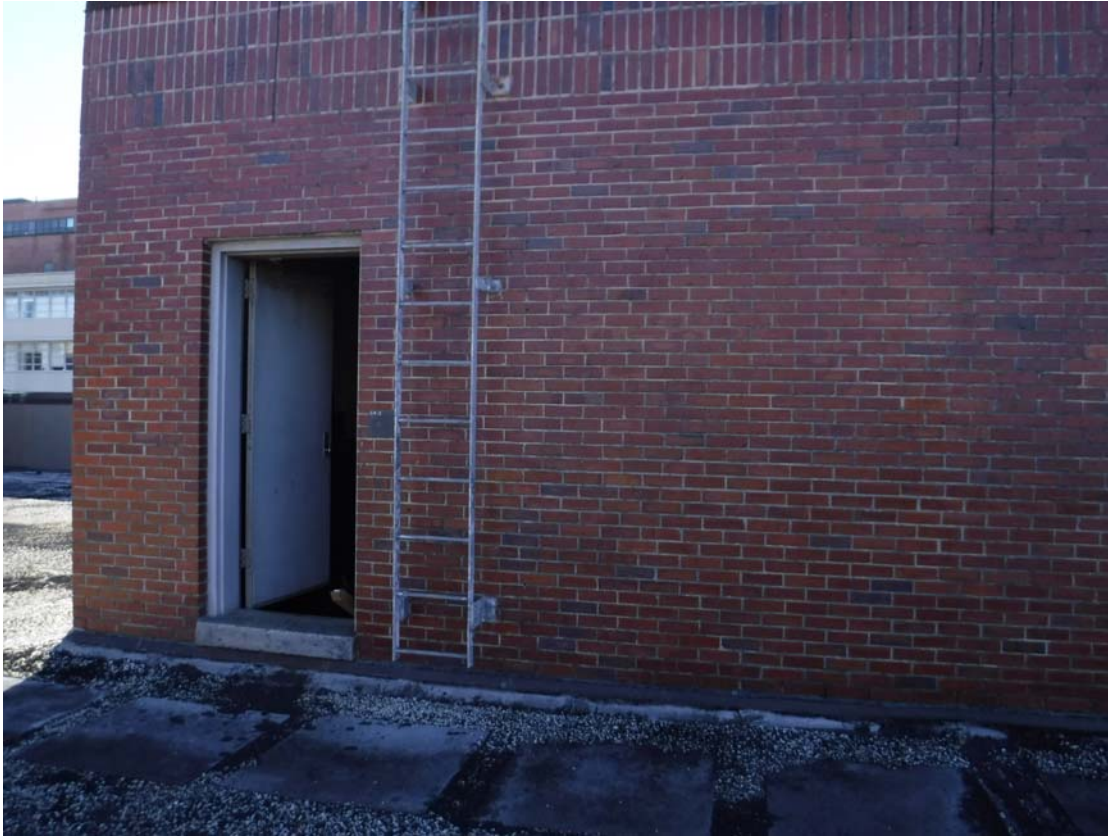
Upper Photo: Exterior View of C4-2

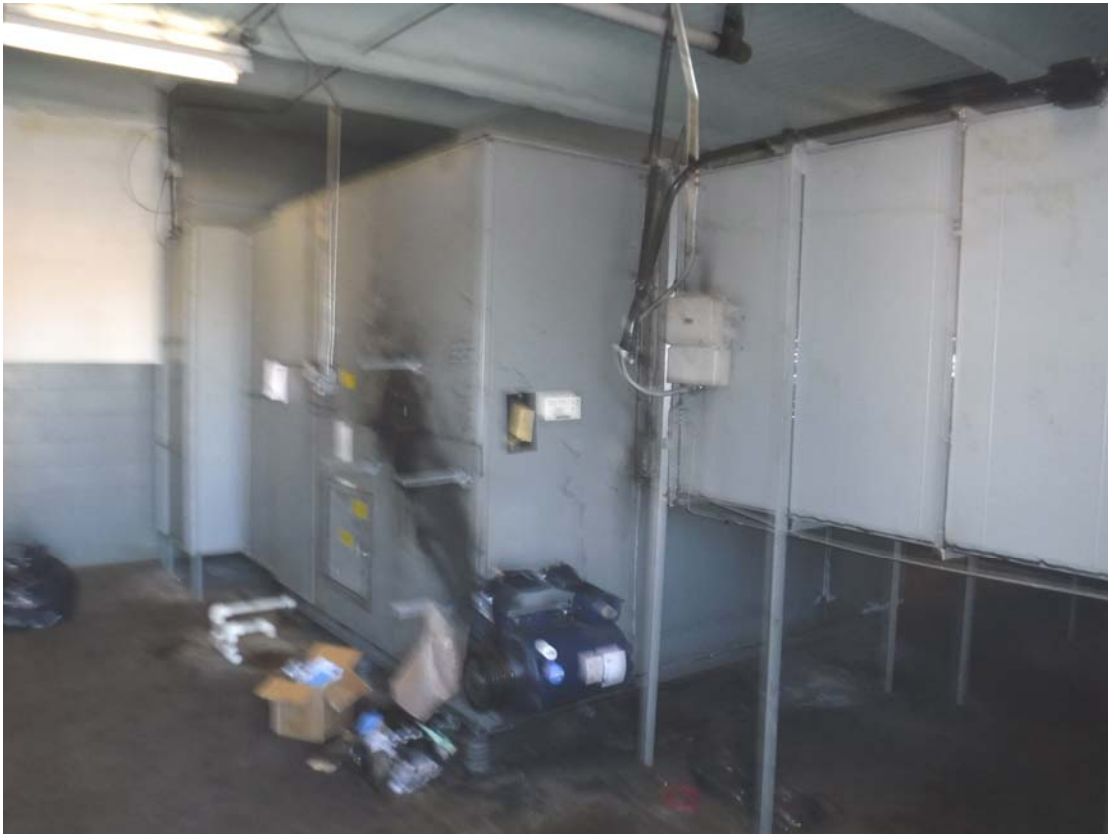
Lower Photo: Interior View of C4-2 (AHU 8)

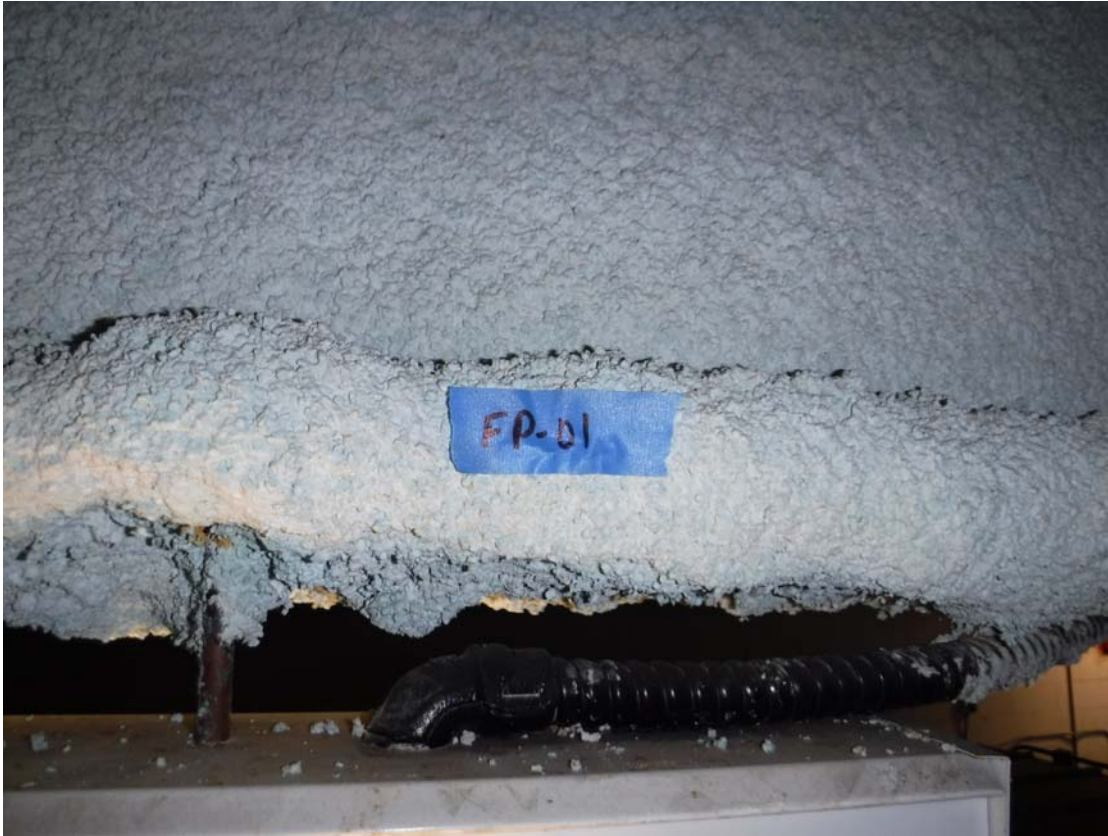
Upper Photo: FP-01-Light Blue
Fireproofing

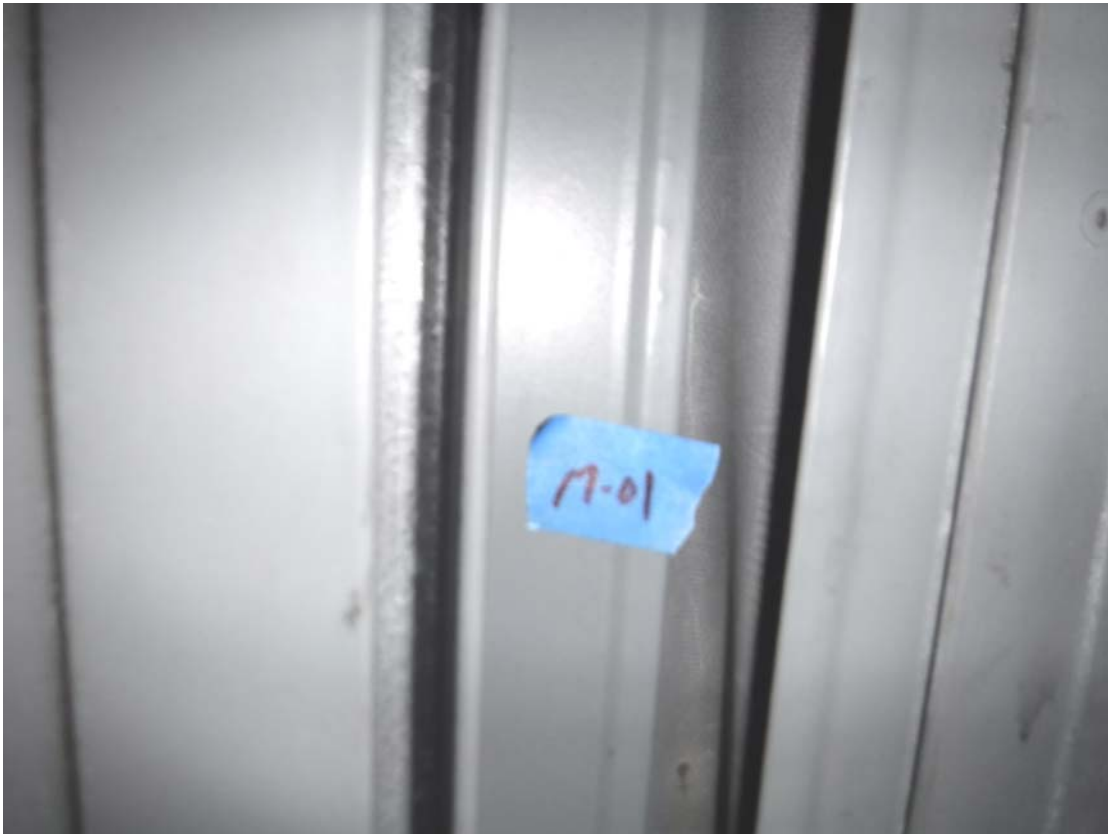
Lower Photo: M-01-Vibration Damper

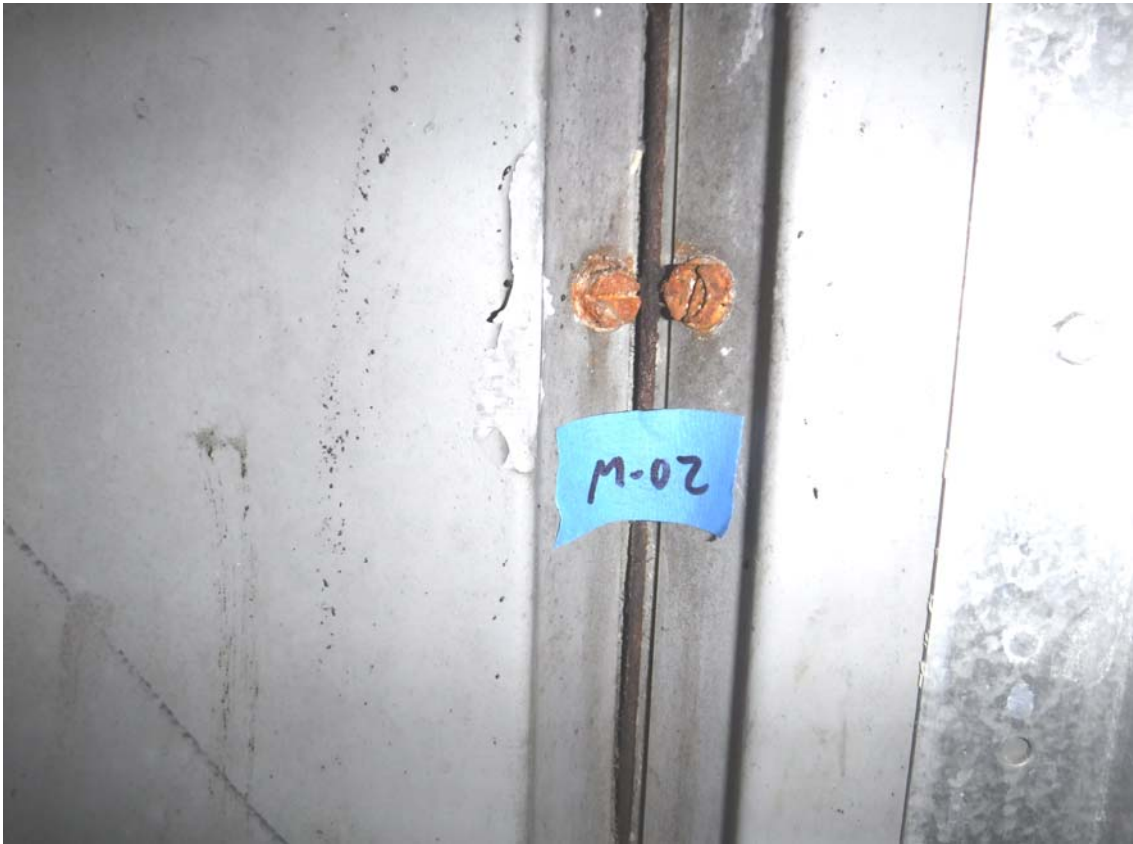
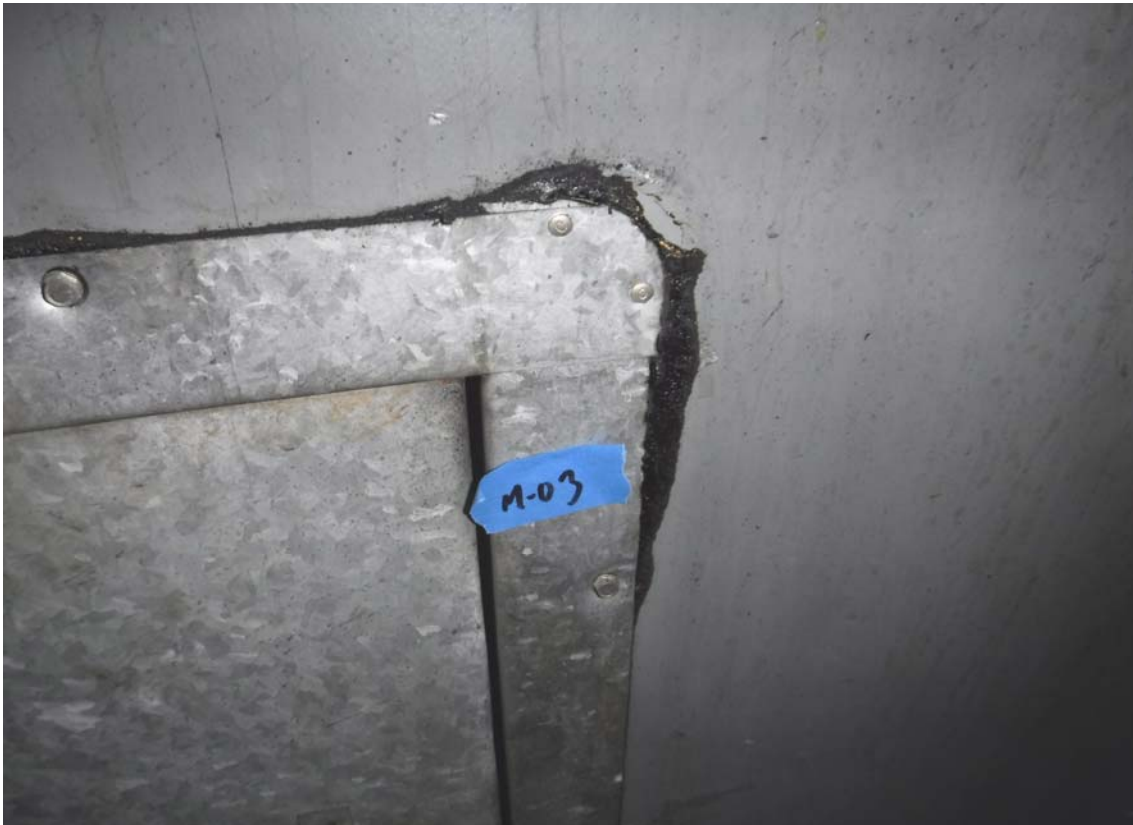
This material is defined by the EPA as a Category I non-friable material. This material does not appear to present a significant issue, as observed, at the time of the survey. We recommend that the identified ACM be maintained as part of an O&M Program and periodically monitored for any changes in condition. Additionally, we recommend that a licensed asbestos abatement contractor properly remove and dispose of the ACM prior to conducting renovation activities that might disturb the ACM.

Upper Photo: M-02-Brown Caulk
Lower Photo: M-03-Black Gasket

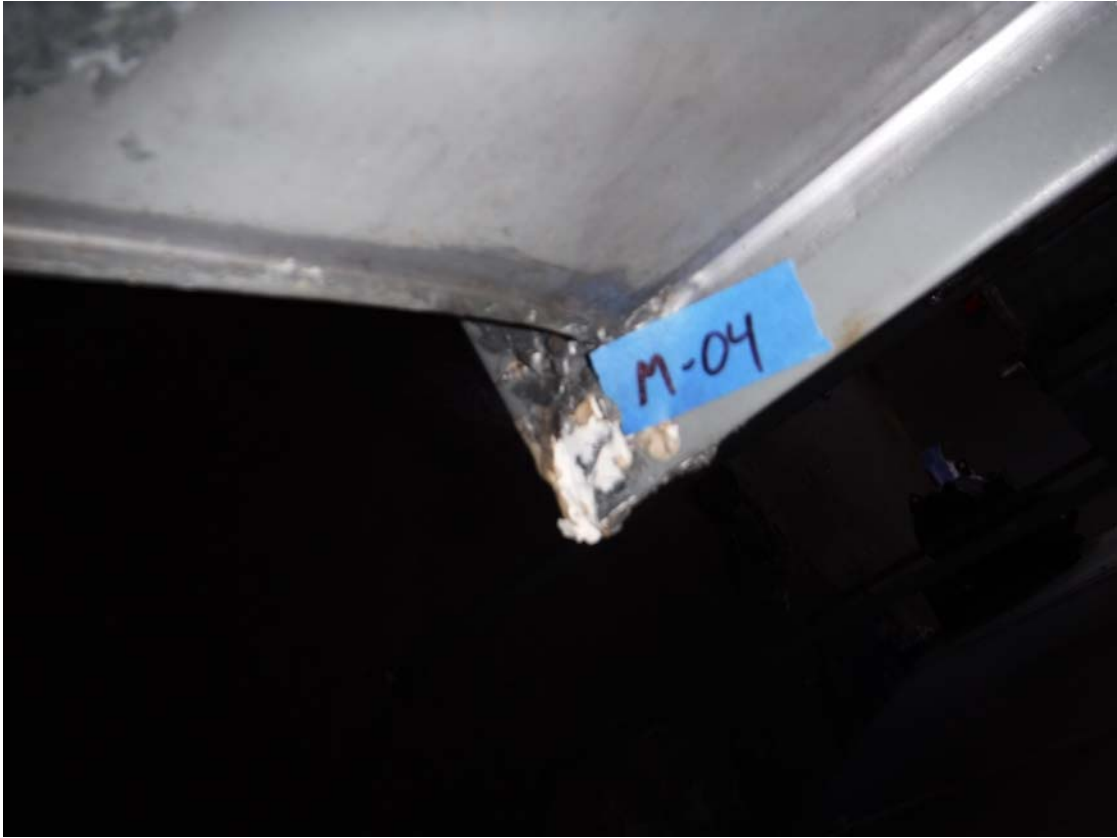
Upper Photo: M-04-Gray over White
Caulk

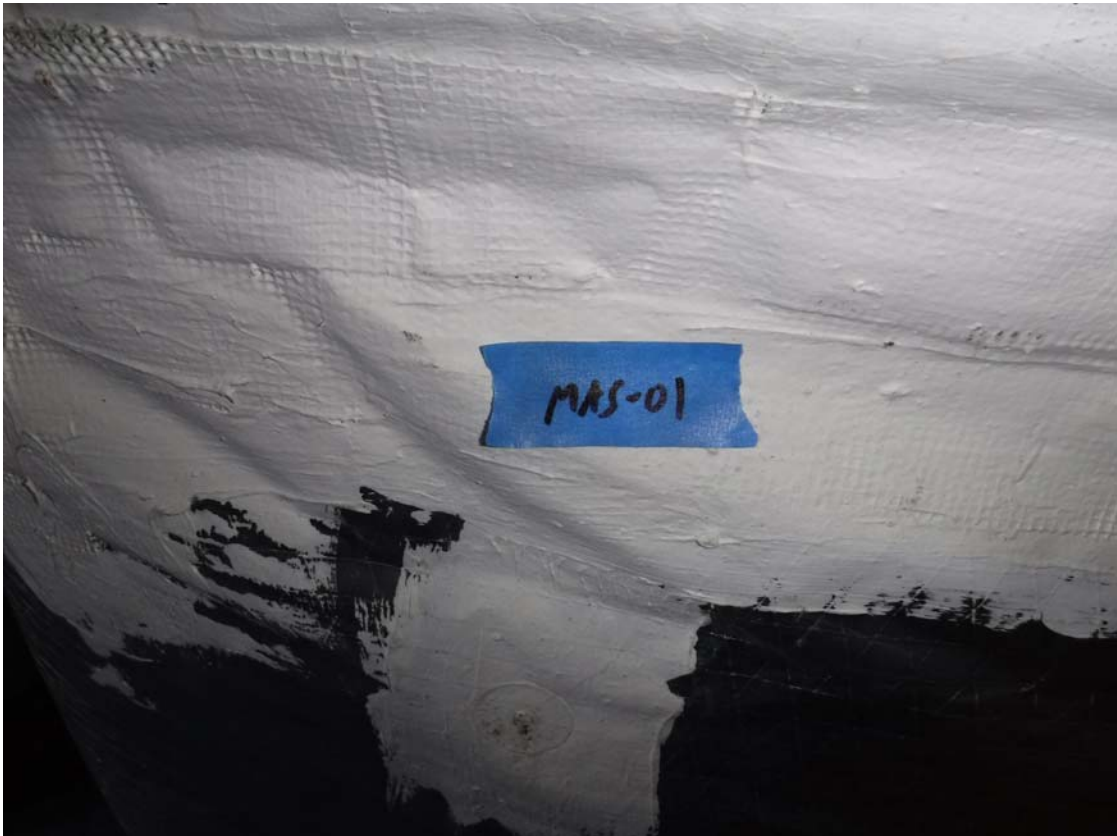
Lower Photo: MAS-01-White Duct
Mastic (Exterior of Ductwork)

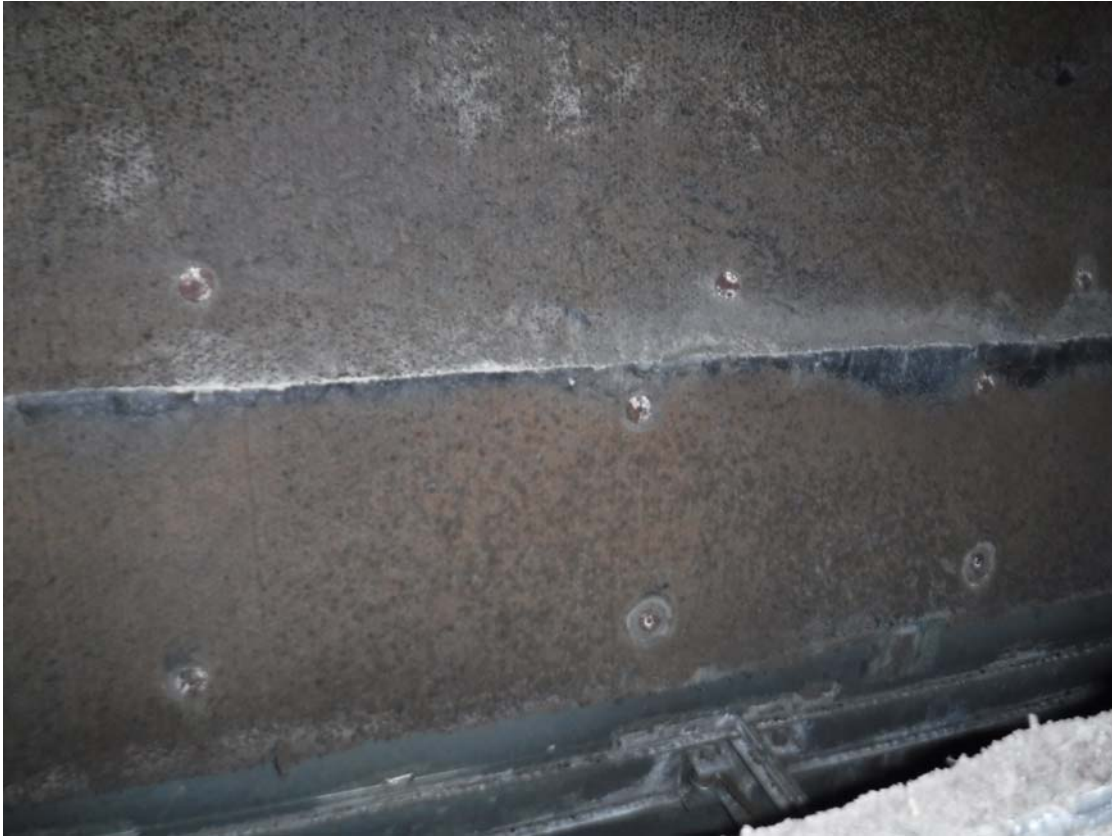
Upper Photo: MAS-02-White Duct
Mastic (Interior of Ductwork)

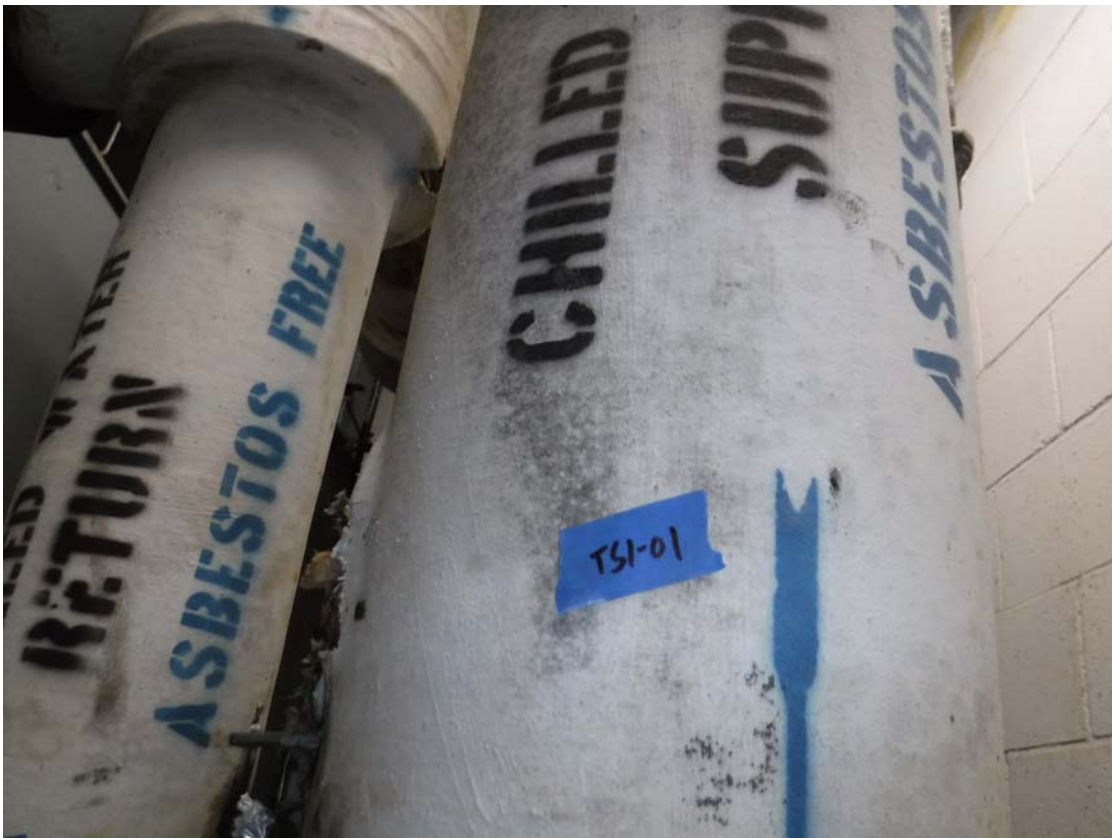
Lower Photo: TSI-01-White Mastic on
Foamglass with White Wrap

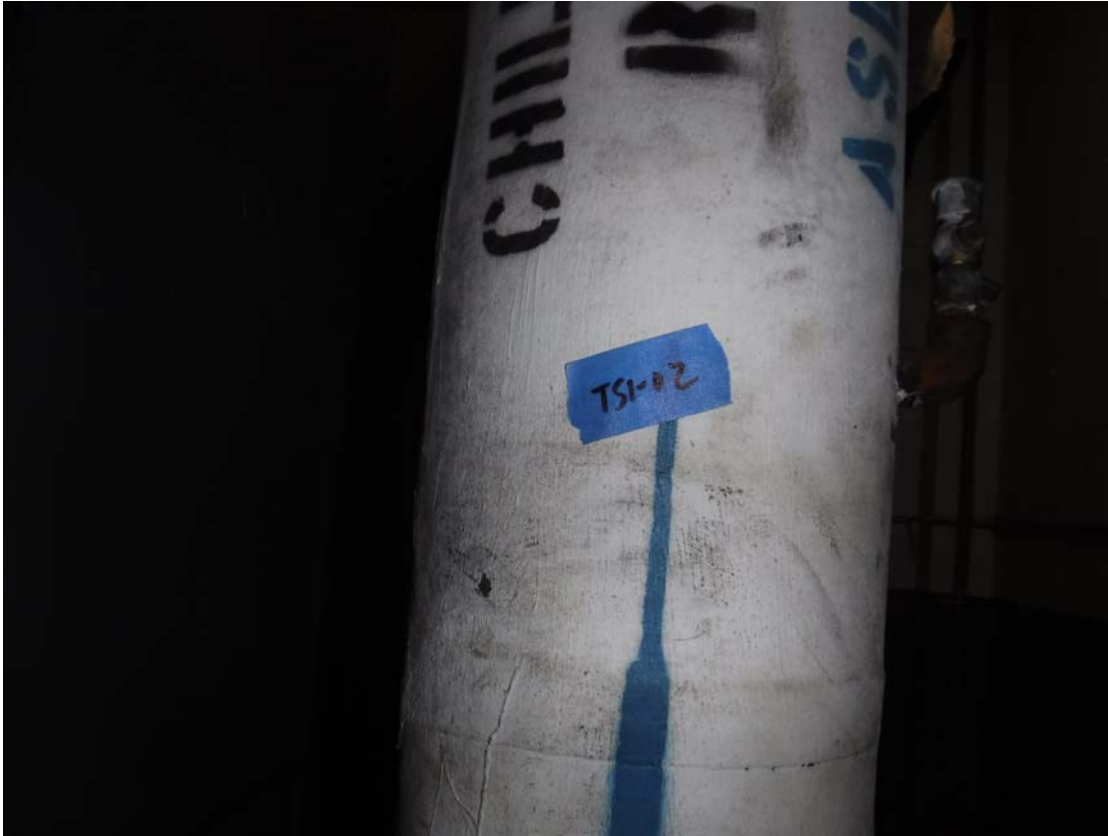
Upper Photo: TSI-02-White Mastic on
Foamglass with White Wrap
