ADDENDUM NUMBER 3 ON INVITATION TO BID ITB20KO-117

TITLE: Chilled Water Pipe Replacement – Dental Science Building Floors 8, 9 and 10

LIMITED PRE-RENOVATION ASBESTOS SURVEY REPORT

Dental Science Chilled Water Pipe Replacement – Floors 8-10 MP04810 University of Florida Gainesville, Florida

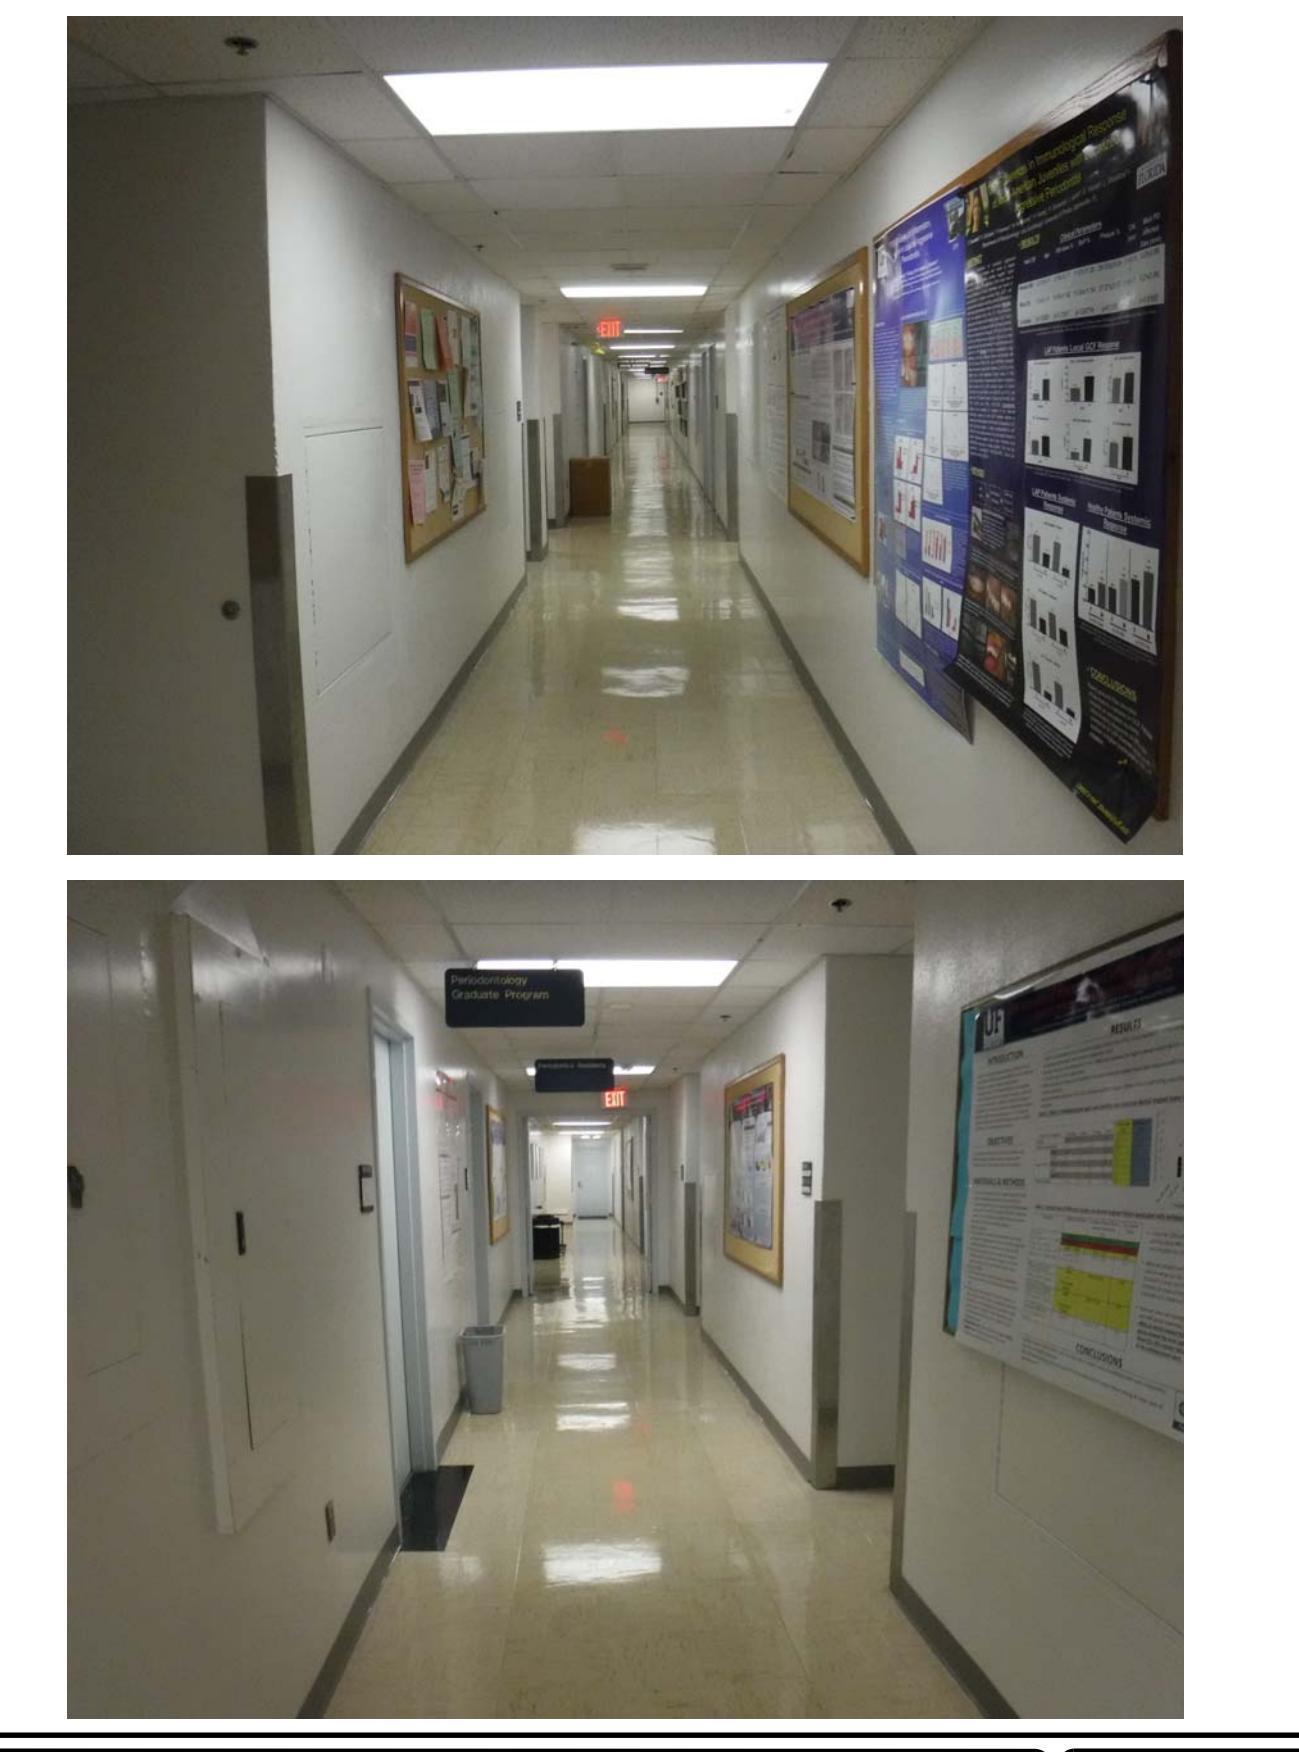
Upper Photo: DSB Floor 10 Hallway North

Lower Photo: DSB Floor 10 Hallway South

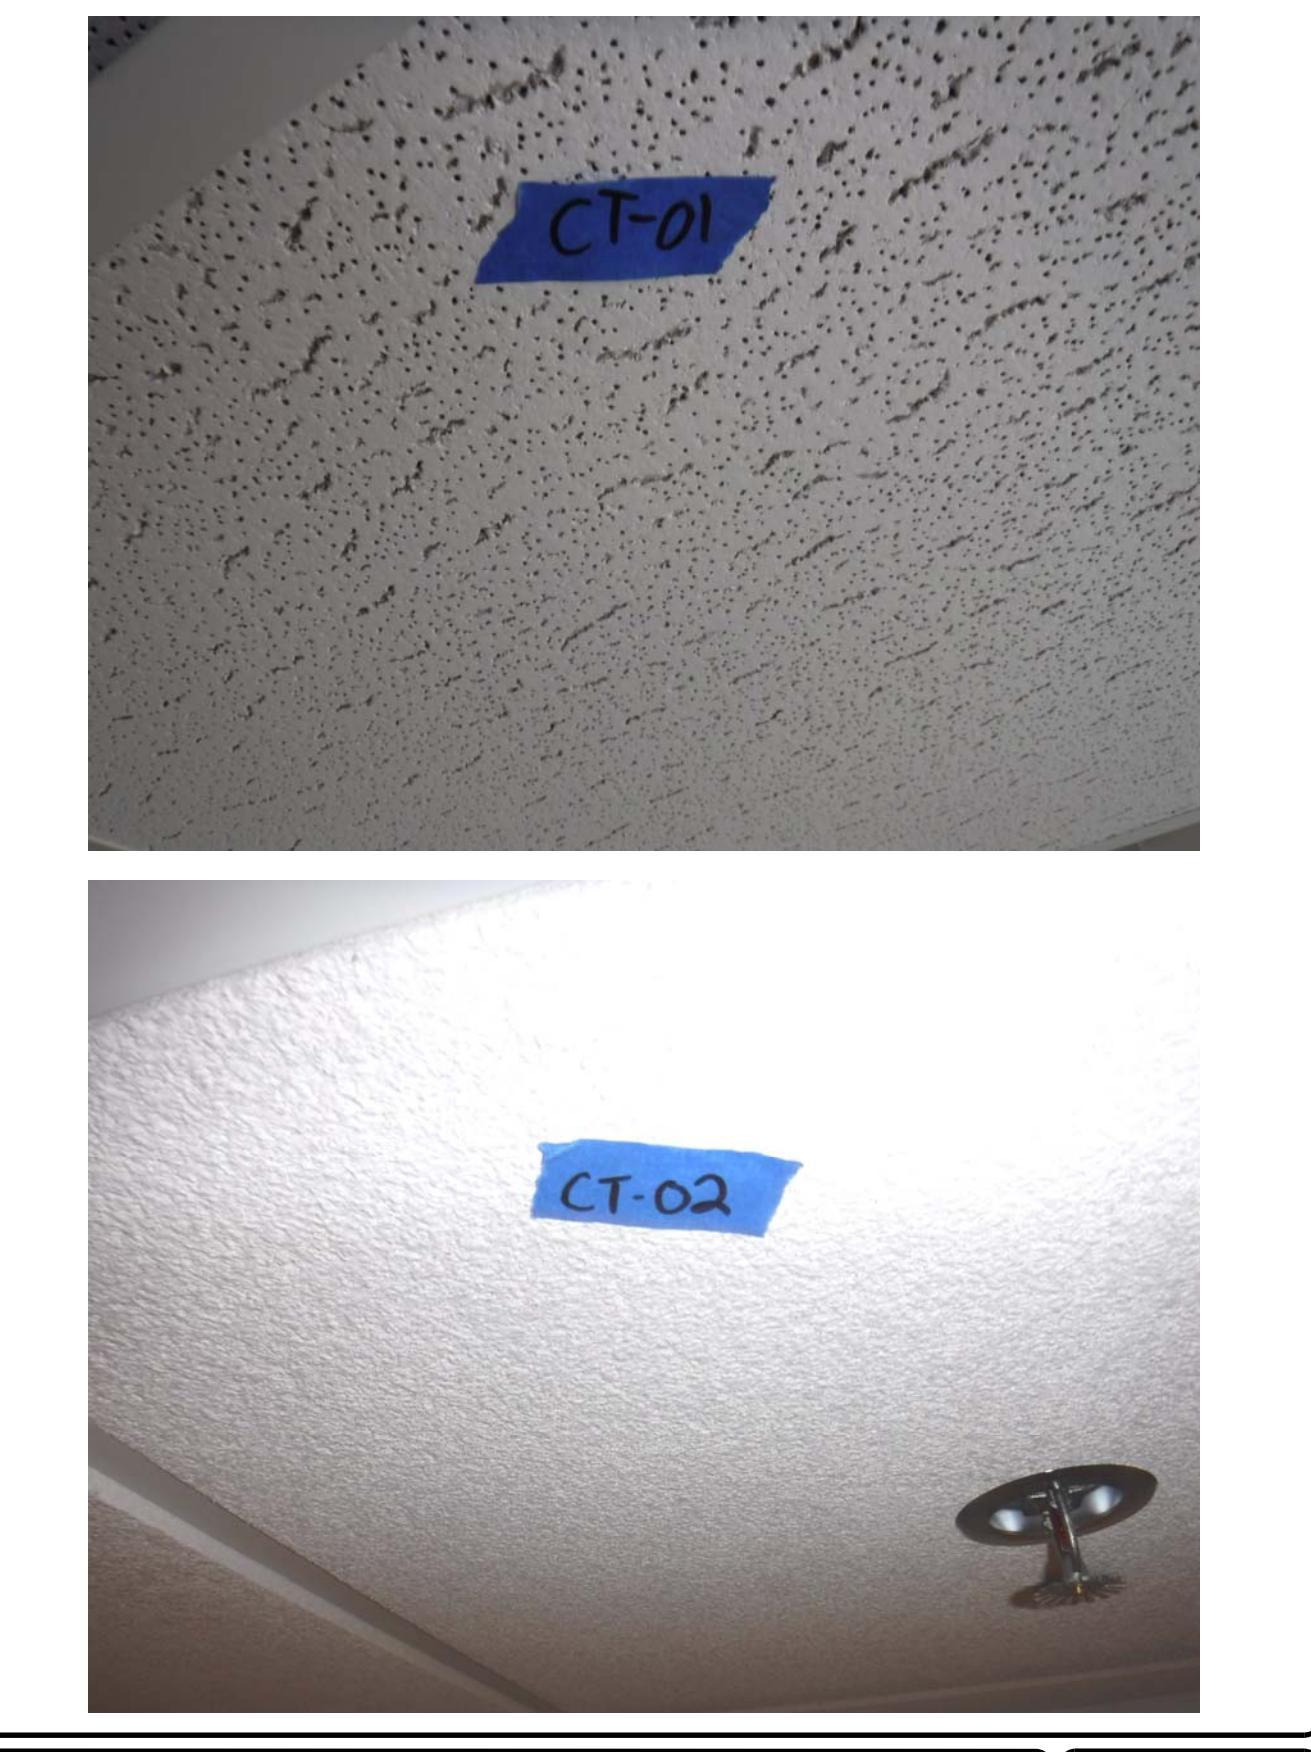
Upper Photo: CT-01-2' x 2' White Fissured Ceiling Tile

Lower Photo: CT-02-2' x 2' White Recessed Ceiling Tile Photograph Date: September 4, 2019

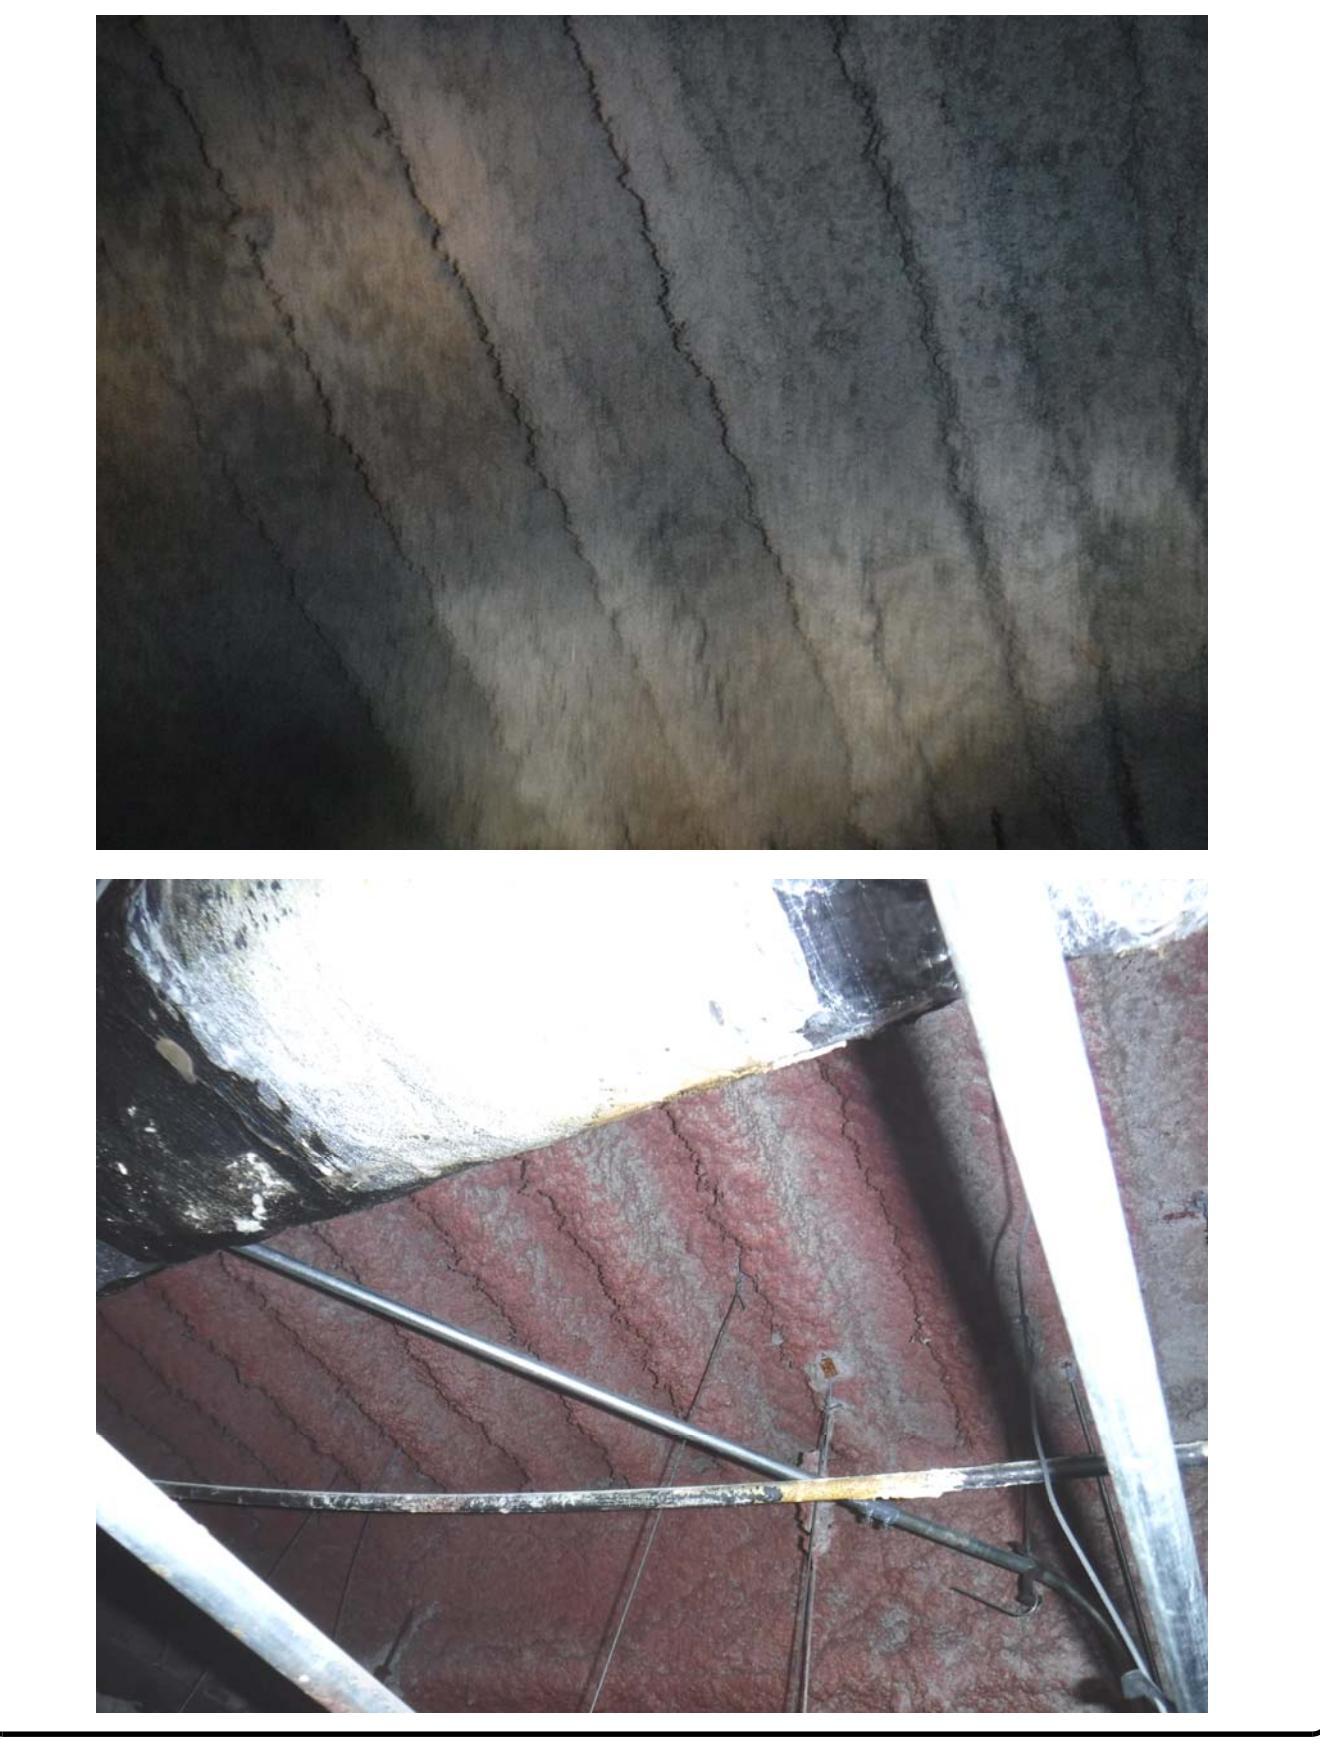
Upper Photo: FP-01-Tan Fireproofing

Lower Photo: FP-02-Red Fireproofing

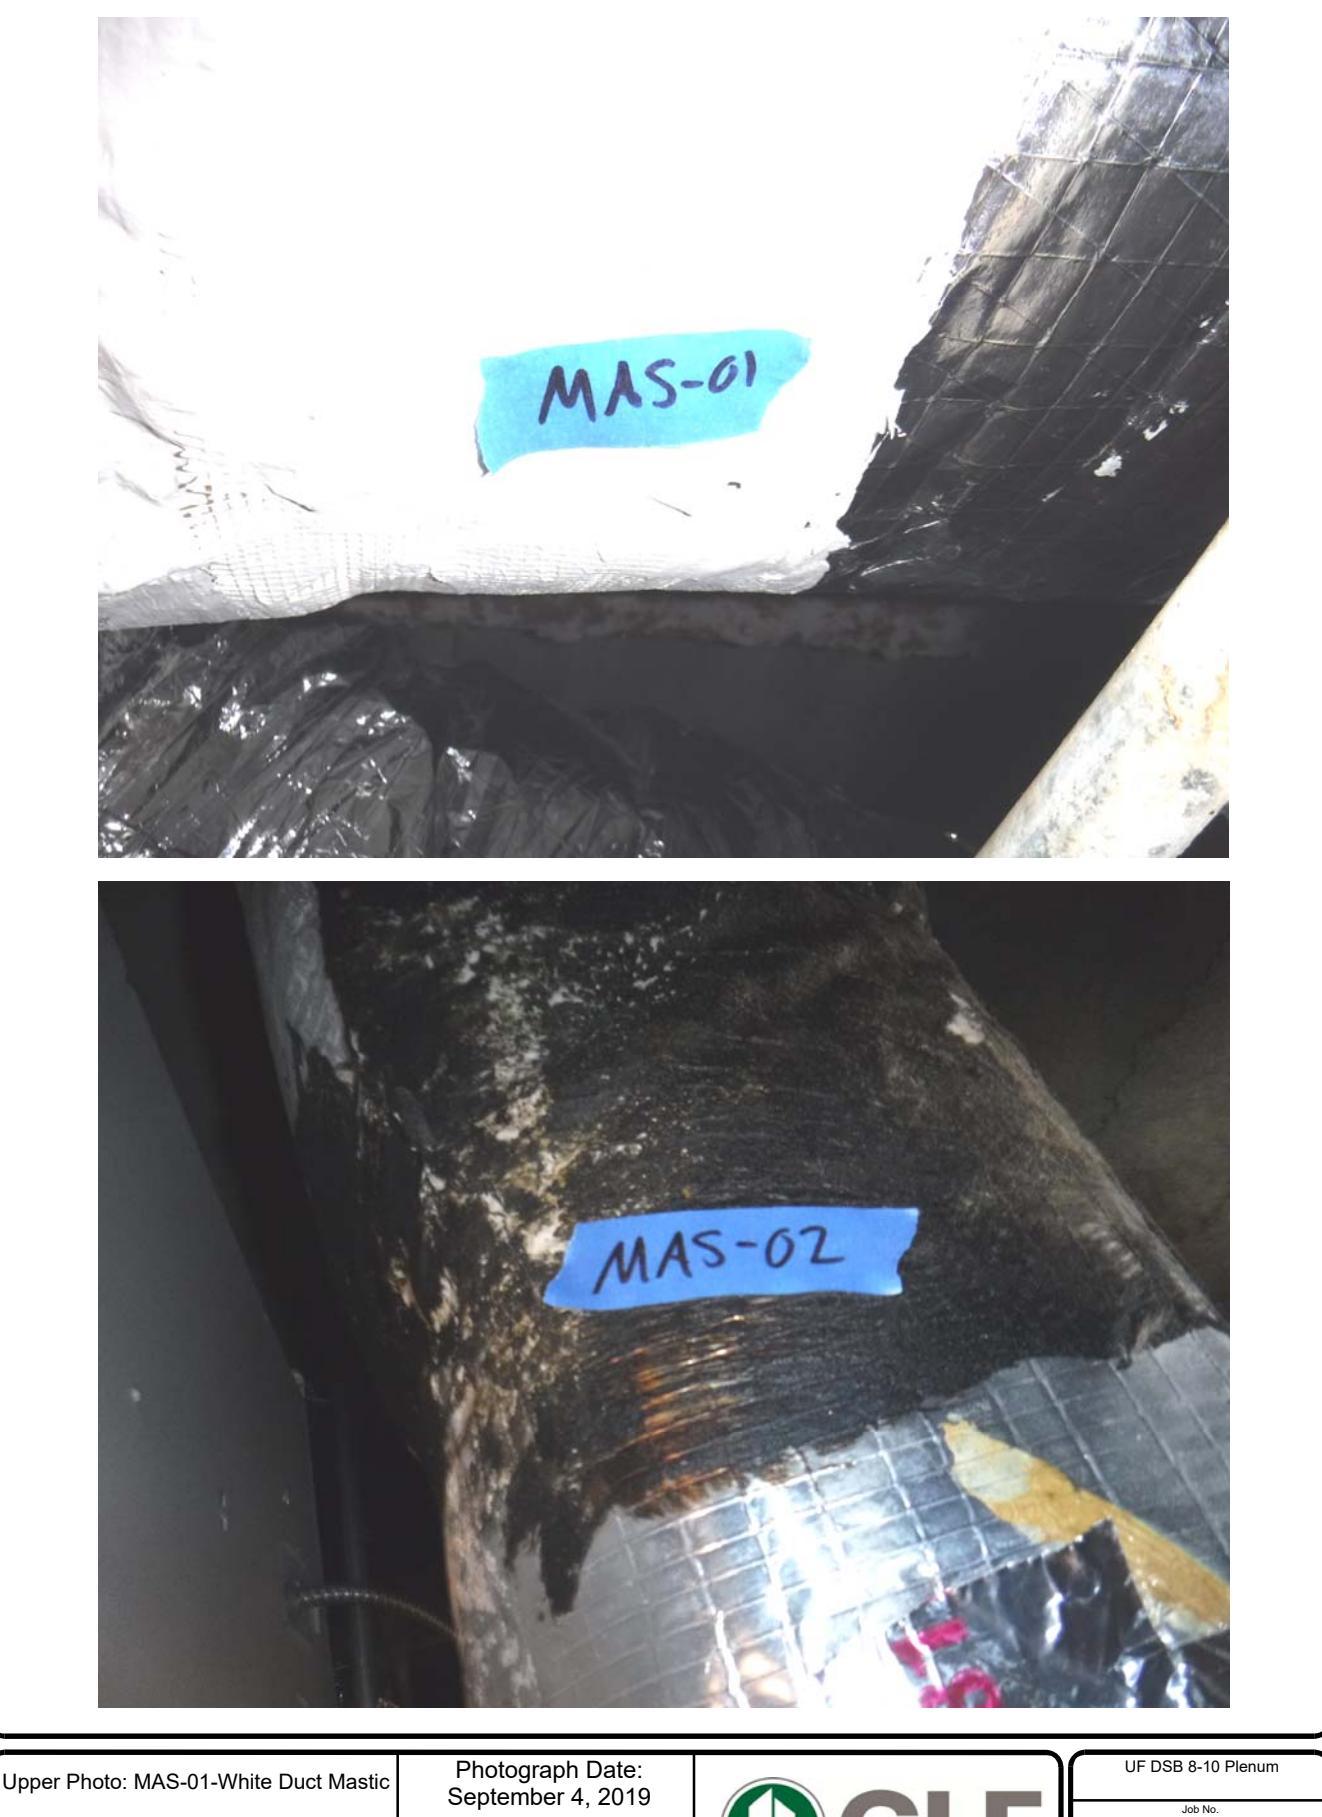
Upper Photo: MAS-01-White Duct Mastic Lower Photo: MAS-02-Black Duct Mastic

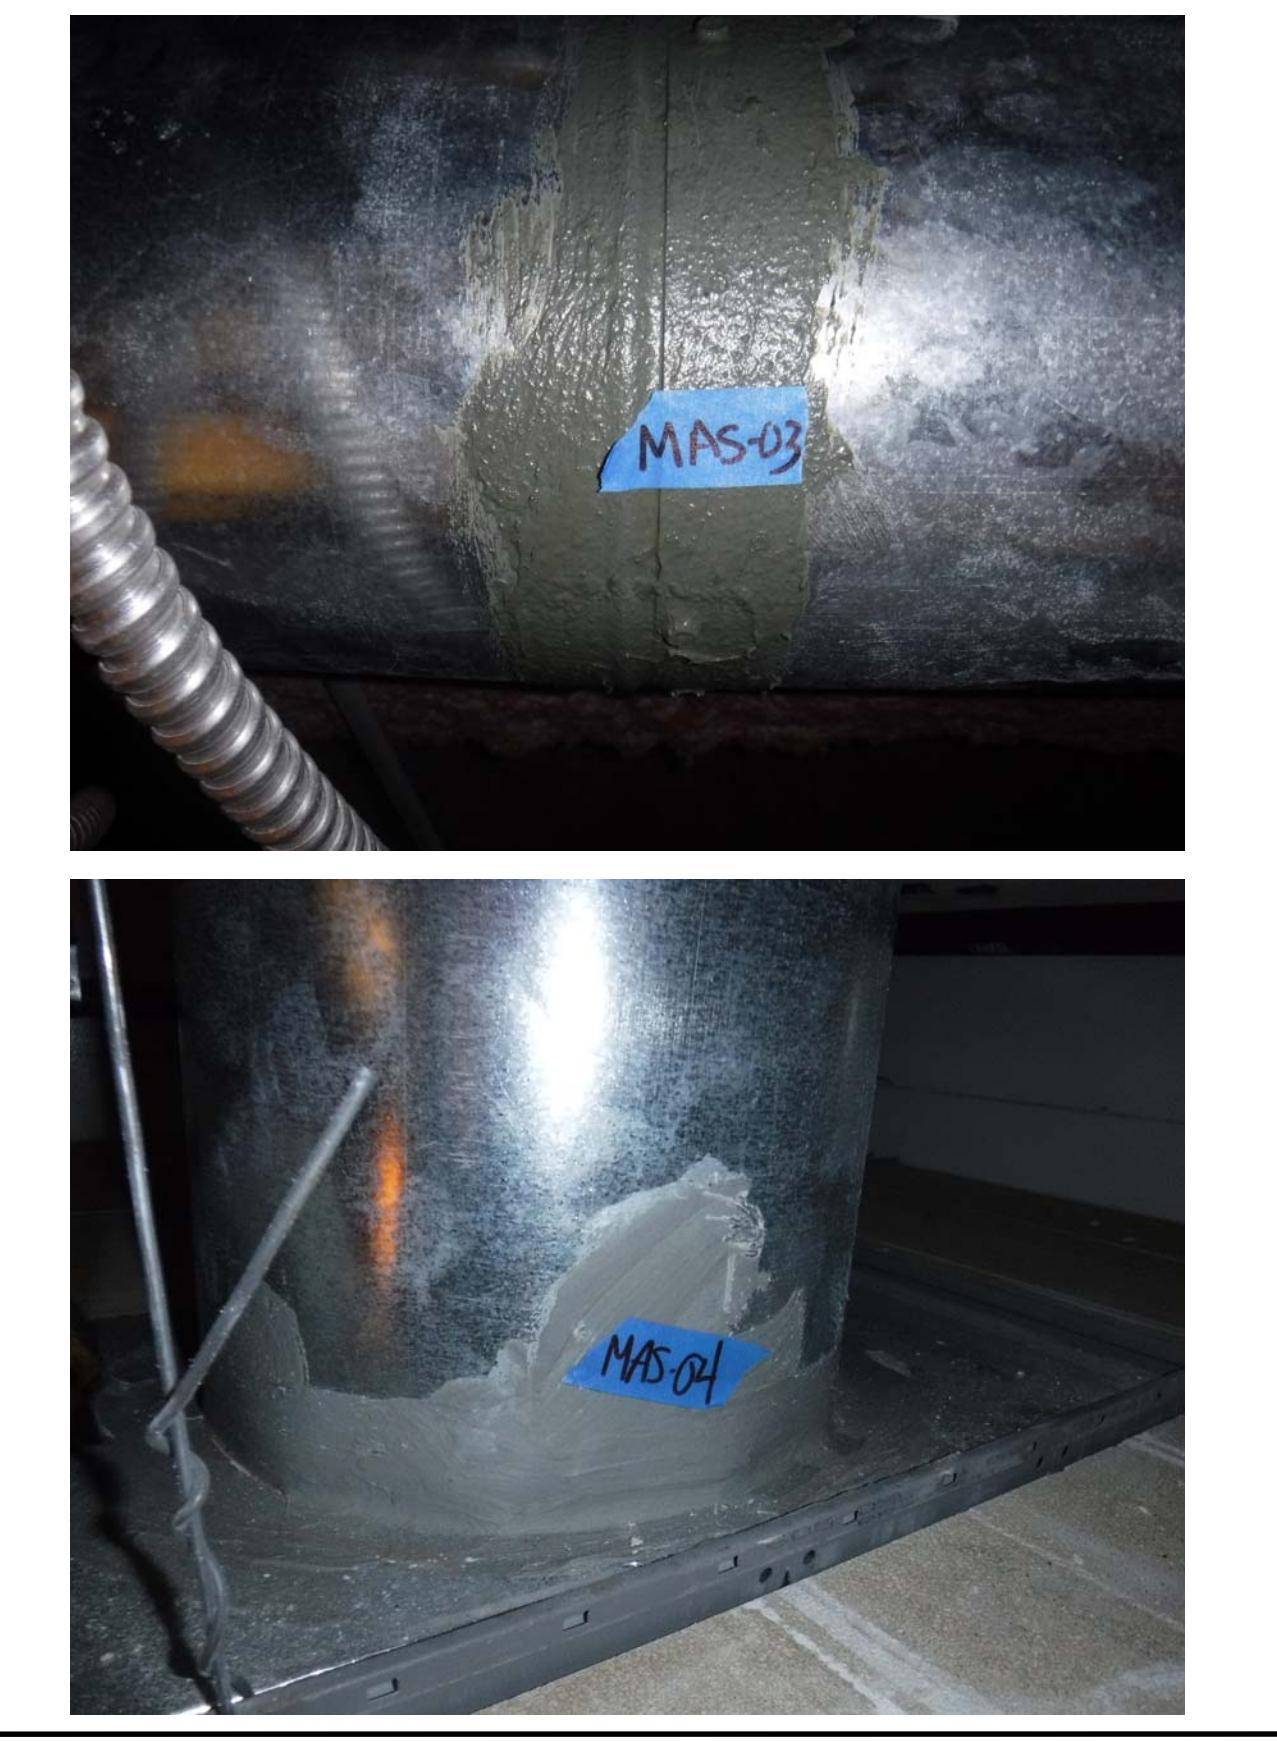
Upper Photo: MAS-03-Gray Mastic on Metal Duct Photograph Date: September 4, 2019

Lower Photo: MAS-04-Gray Fume Hood Prepared By: Exhaust Mastic GLE Associates, Inc.

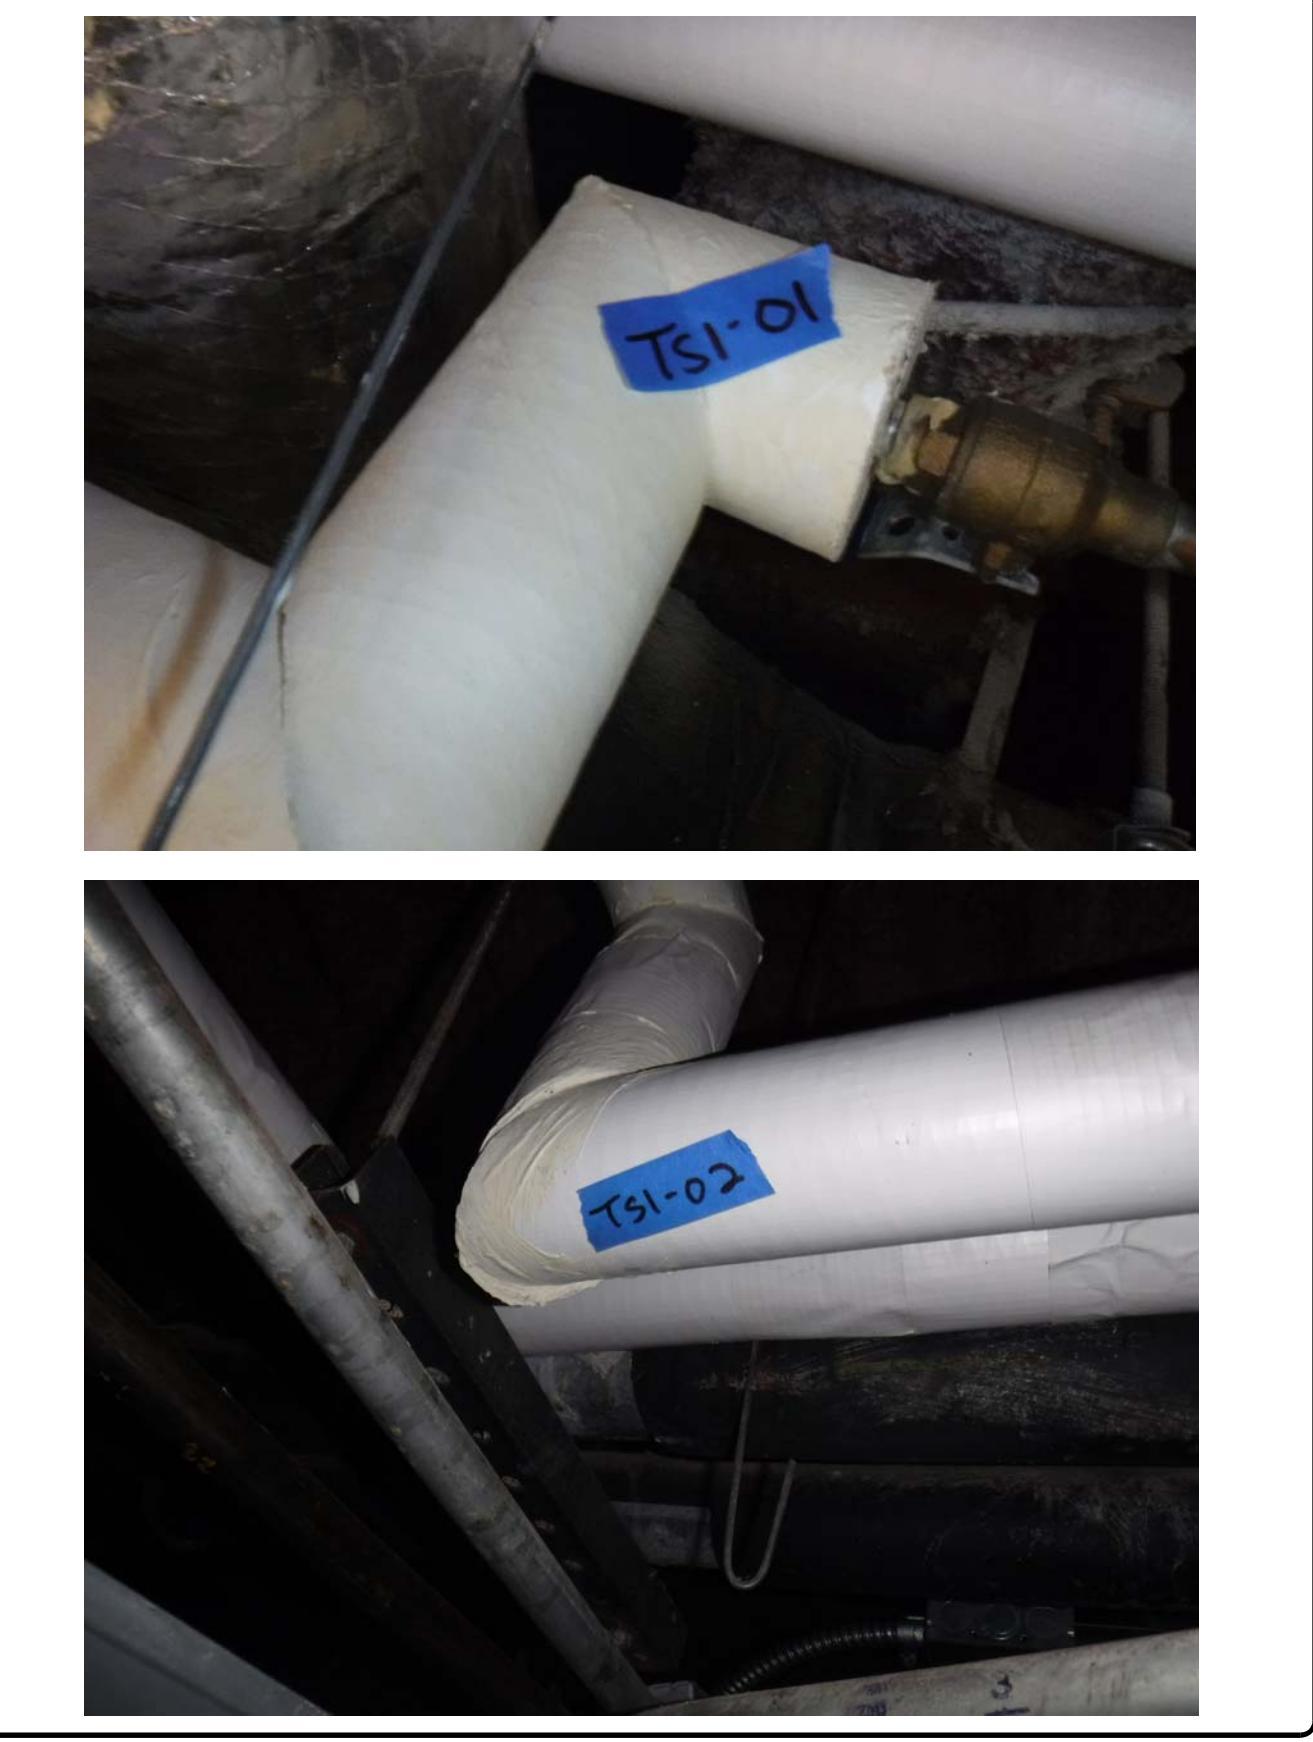
Upper Photo: TSI-01-White Mastic on Fiberglass TSI

Lower Photo: TSI-02-Tan Mastic on Fiberglass TSI

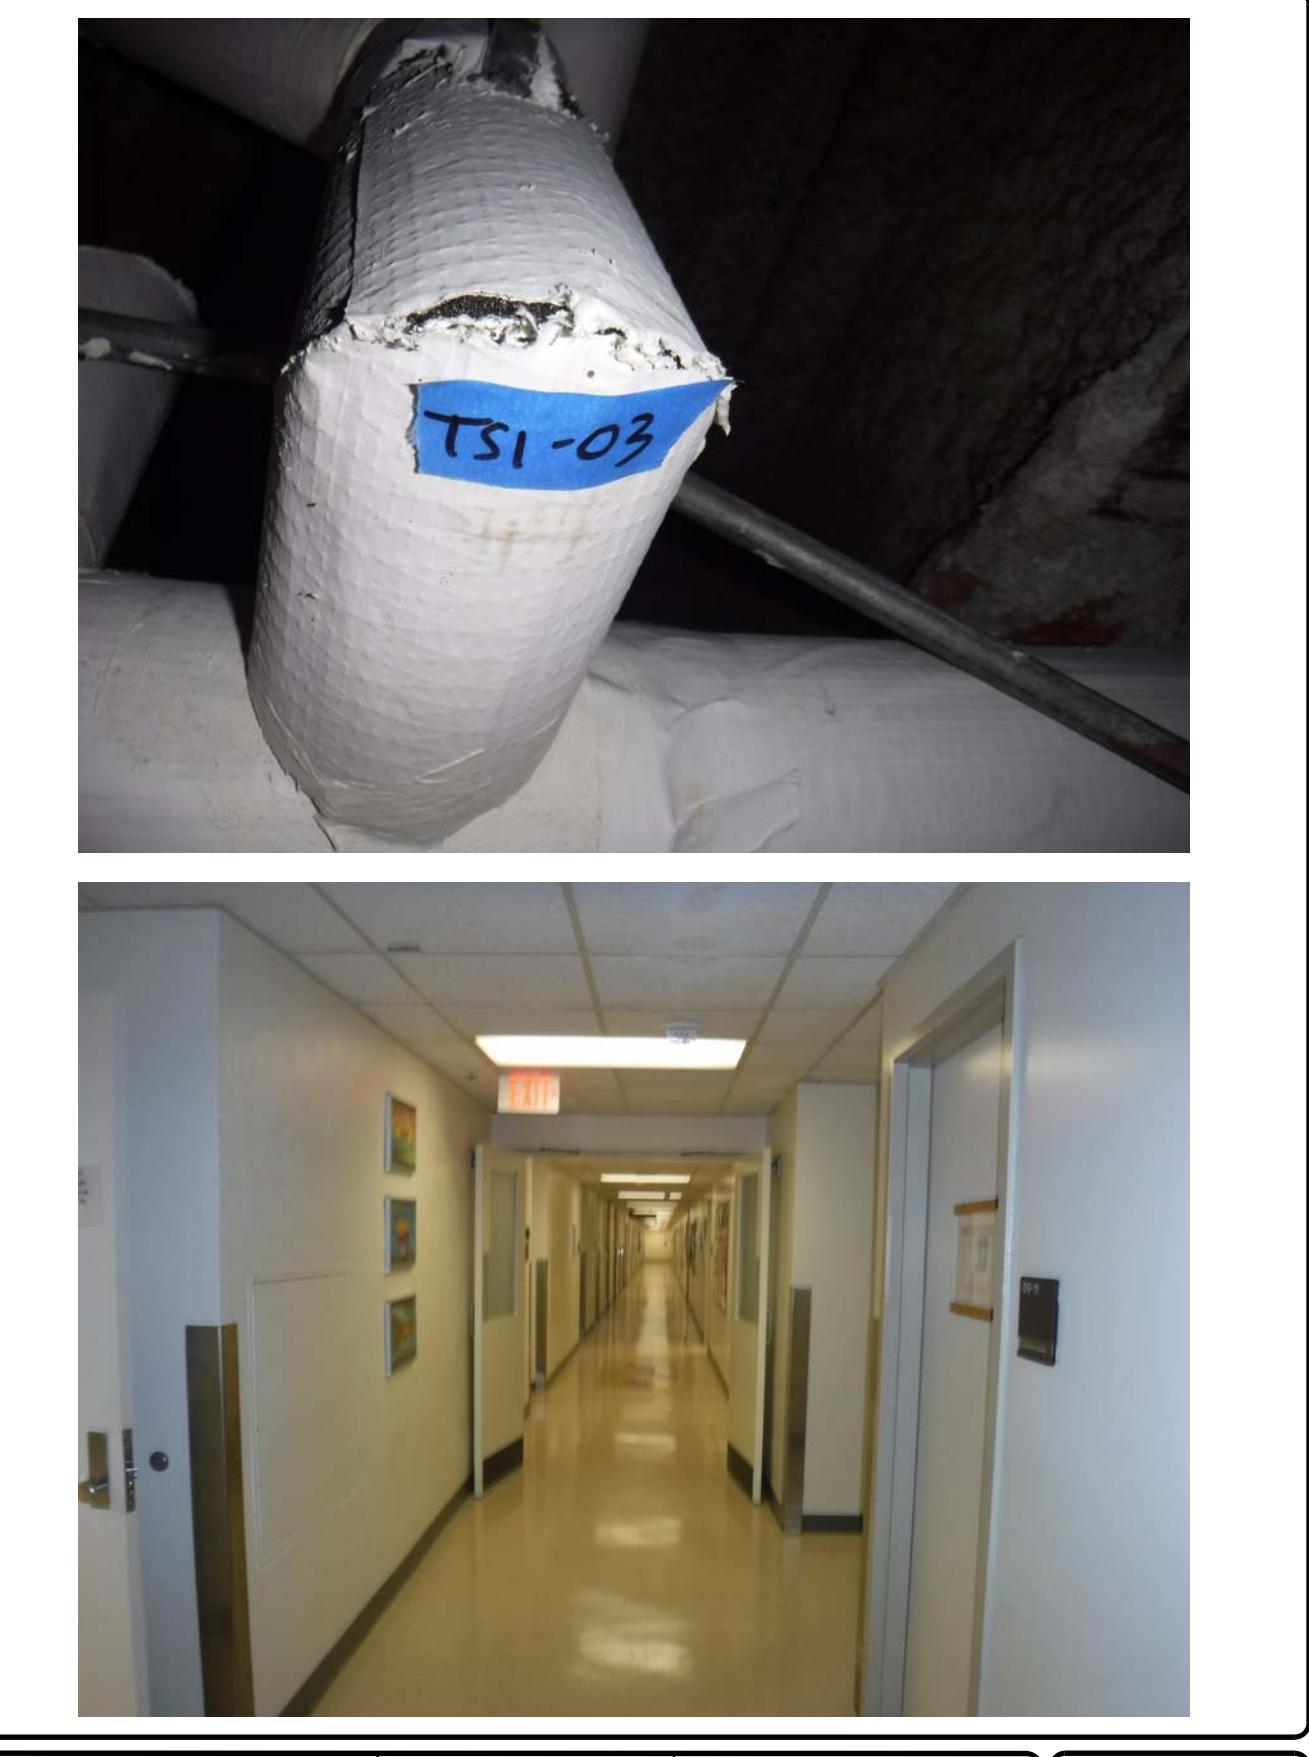
Upper Photo: TSI-03-White Mastic on Foamglass TSI

Lower Photo: DSB Floor 9 Hallway

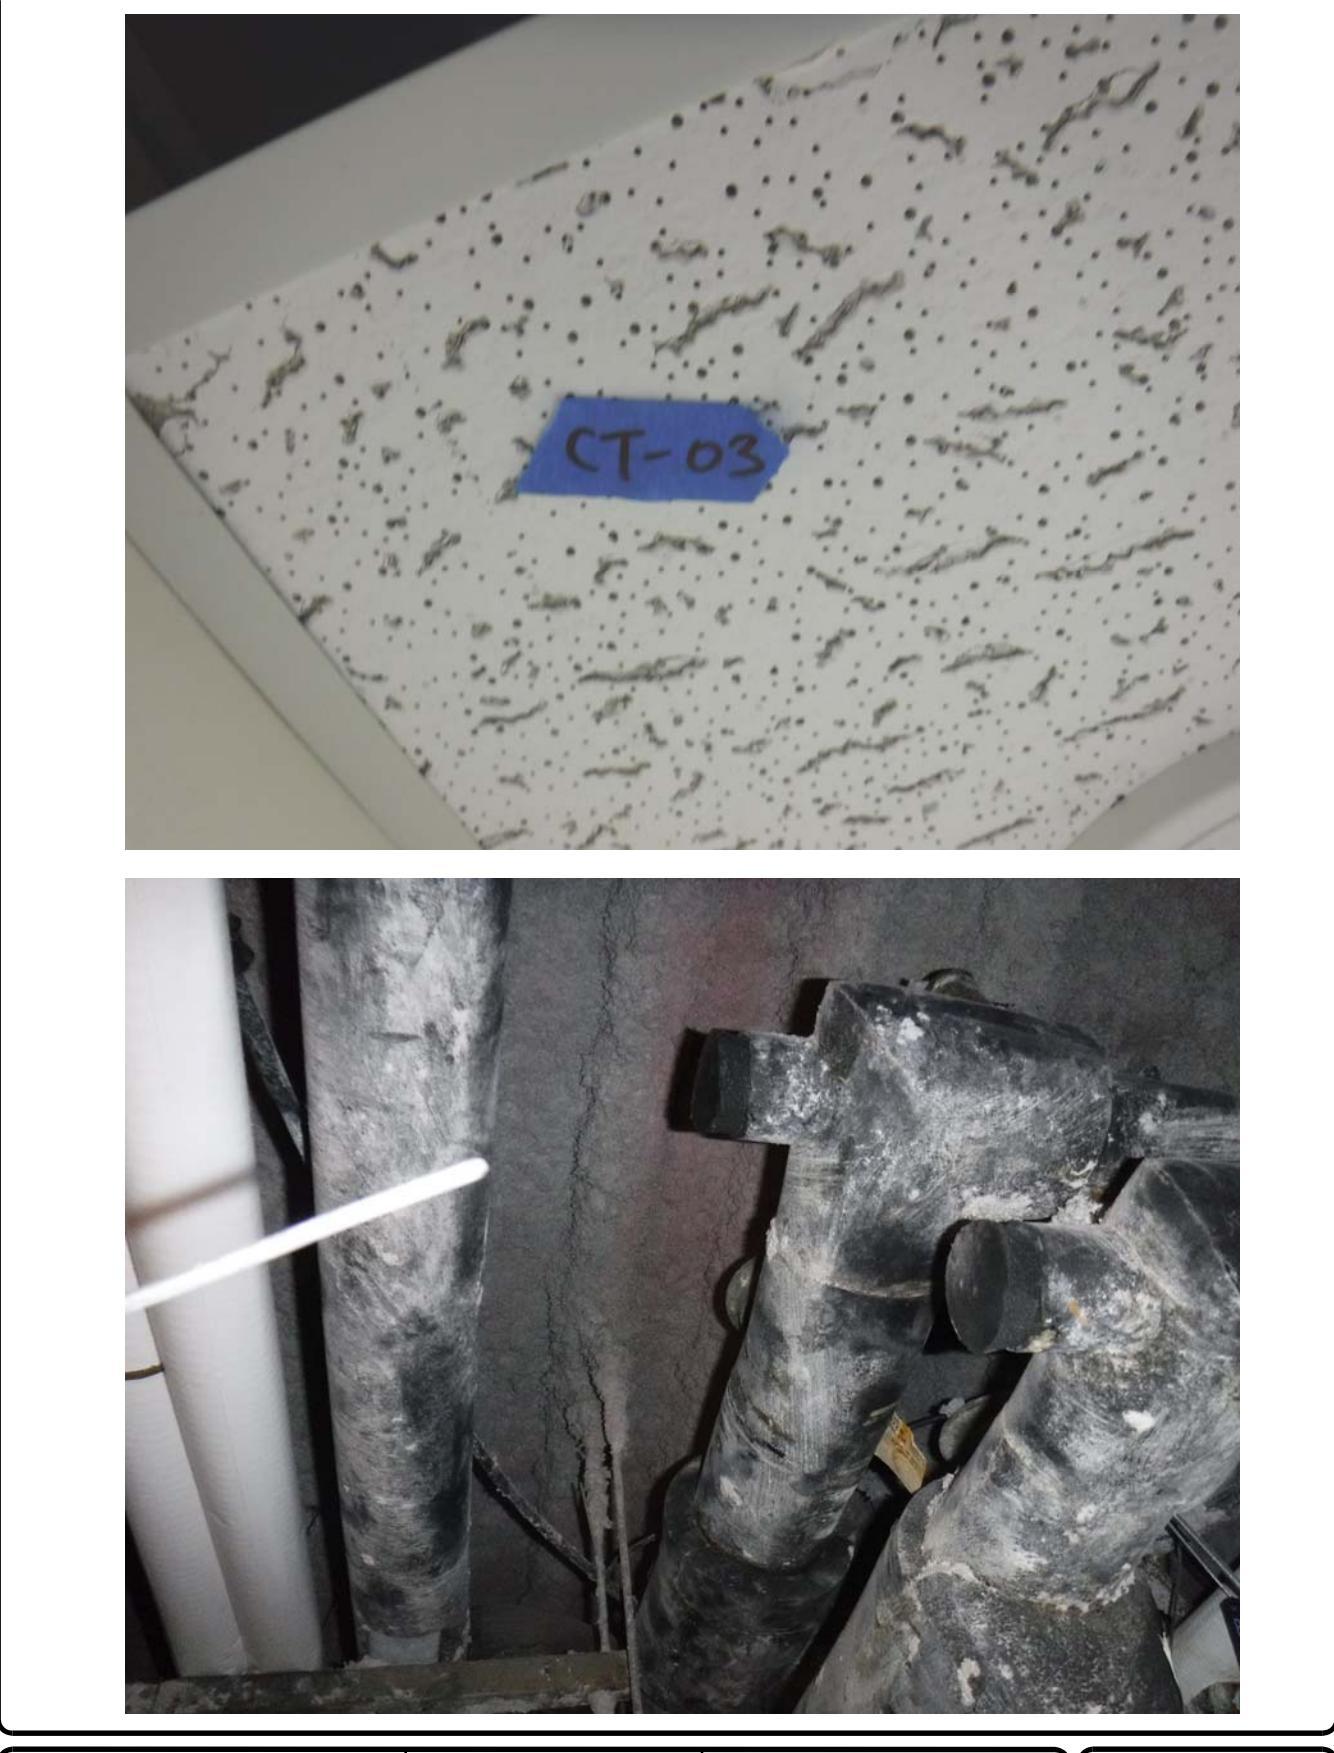
Upper Photo: CT-03-2' x 2' White Fissured Ceiling Tile

Lower Photo: FP-03-Red Fireproofing

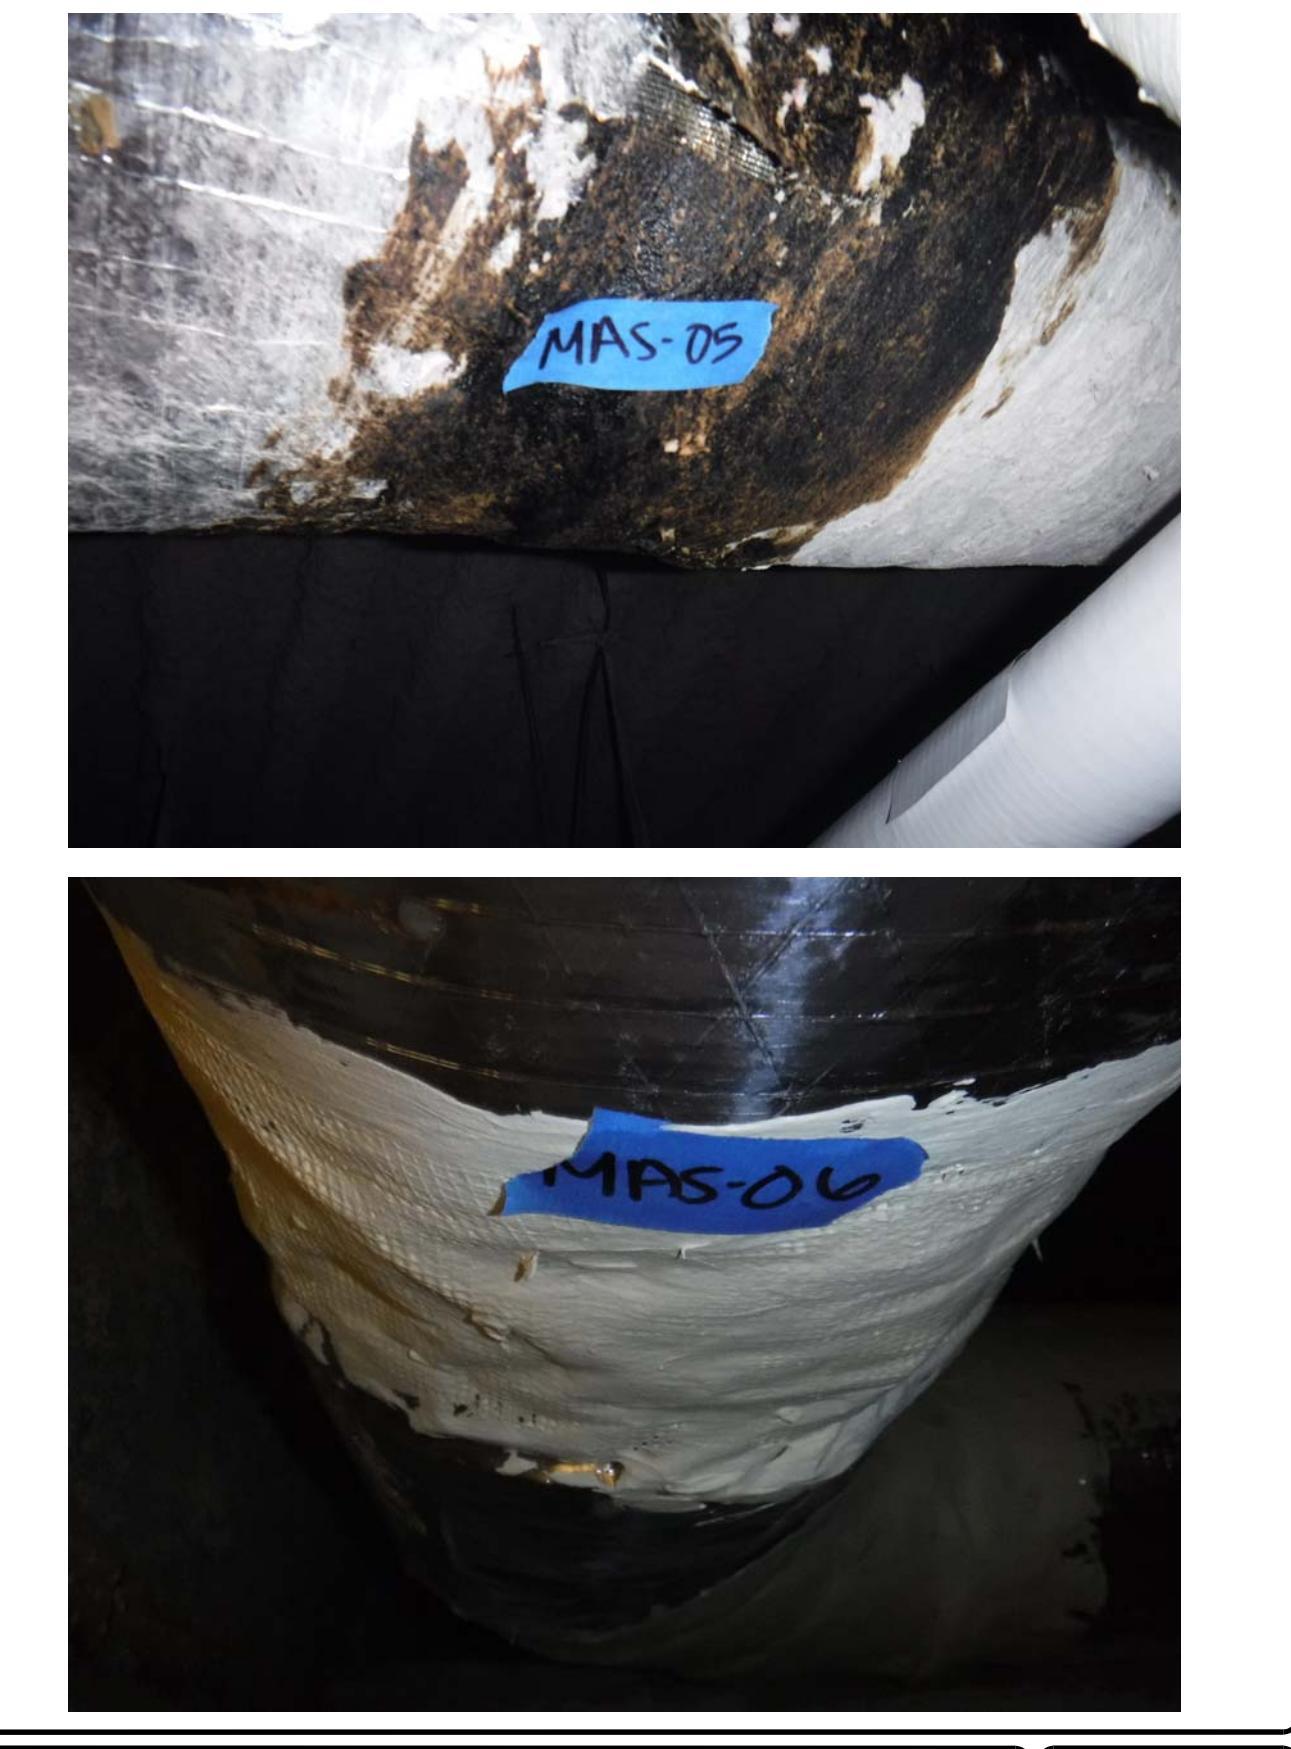
Upper Photo: MAS-05-Black Duct Mastic

Lower Photo: MAS-06-White Duct Mastic

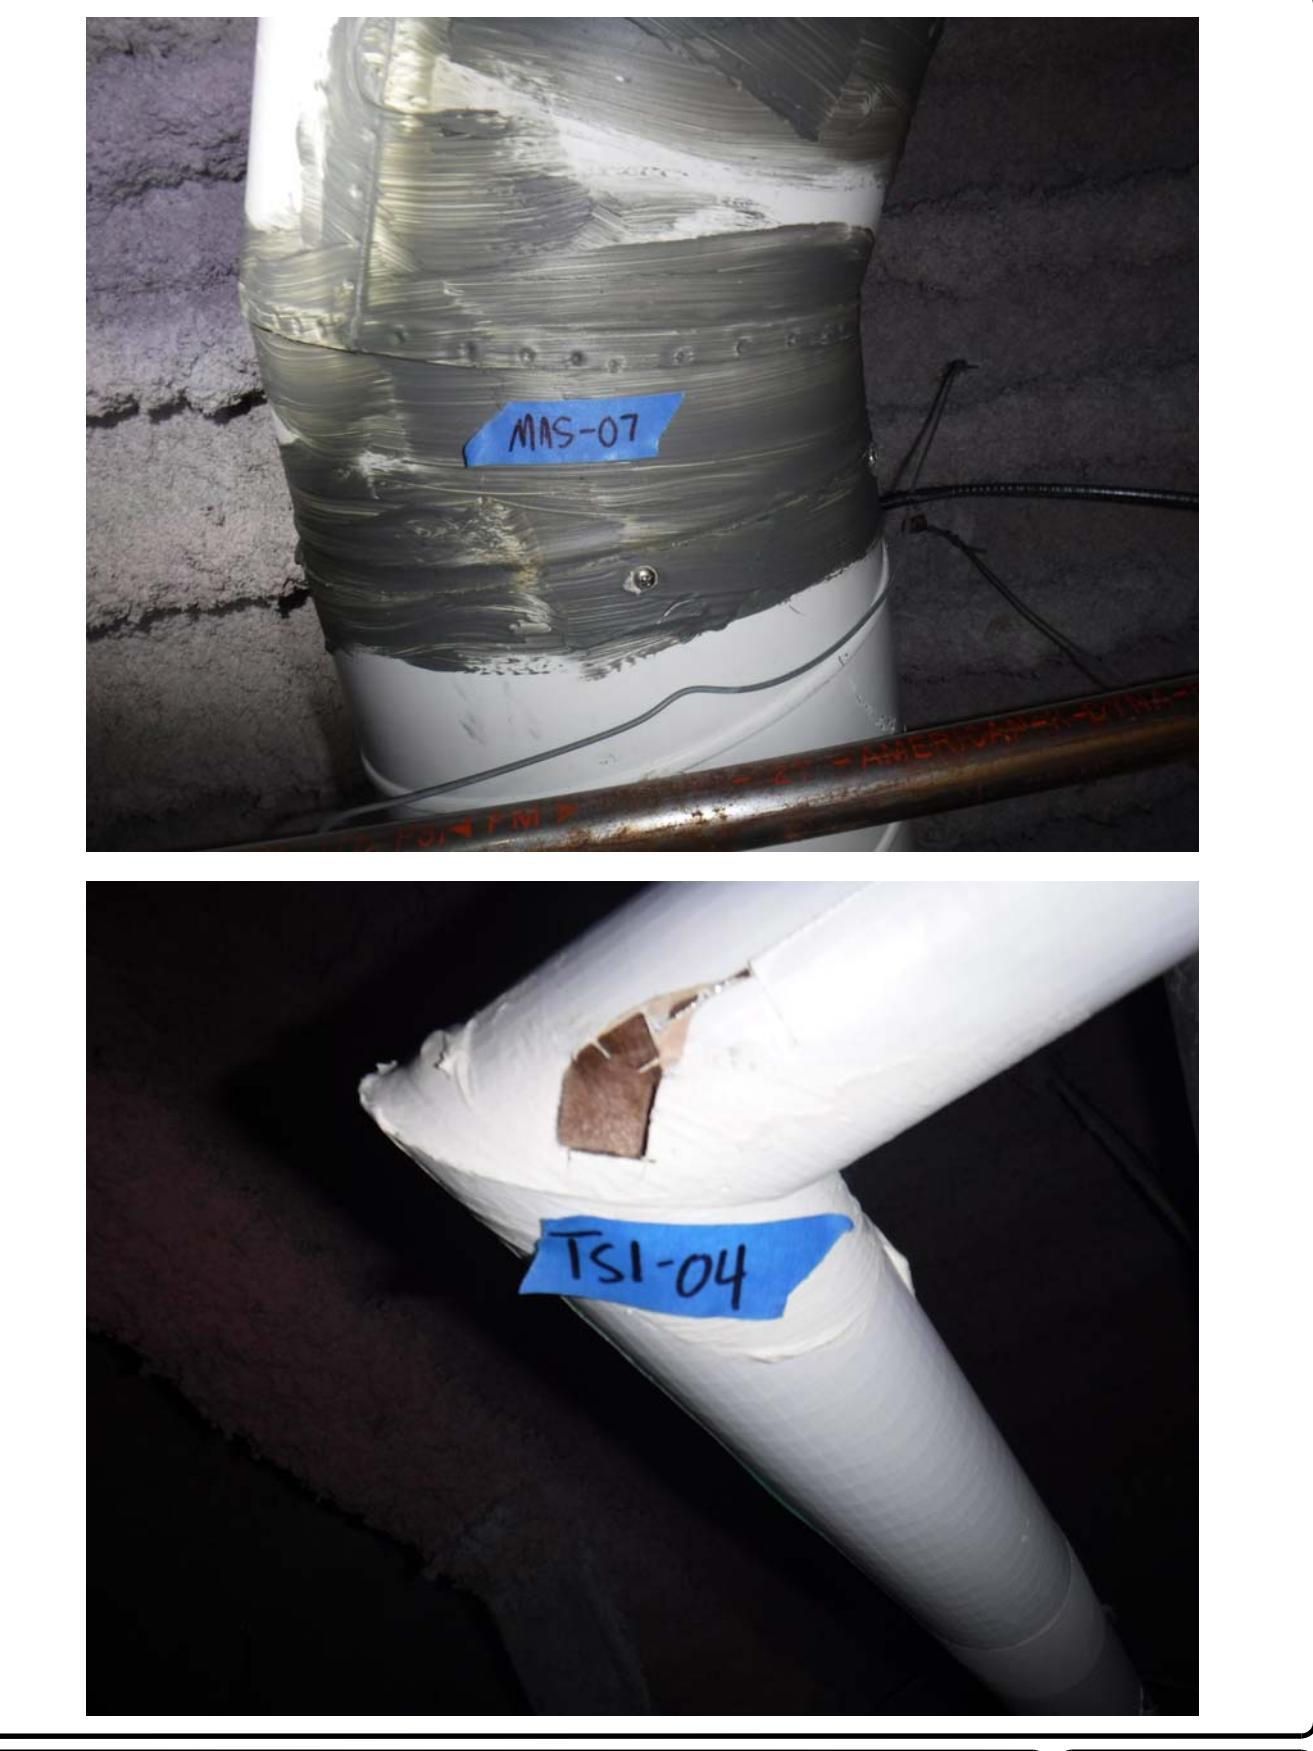
UF DSB 8-10 Plenum Job No. 19140-01824 Figure 10

Upper Photo: MAS-07-Gray Mastic on Metal Duct Photograph Date: September 4, 2019

Lower Photo: TSI-04-White Mastic on Fiberglass TSI
