ADDENDUM NUMBER 3 ON INVITATION TO BID ITB20KO-117

TITLE: Chilled Water Pipe Replacement – Dental Science Building Floors 8, 9 and 10

LIMITED PRE-RENOVATION ASBESTOS SURVEY REPORT

Dental Science Chilled Water Pipe Replacement – Floors 8-10 MP04810 University of Florida Gainesville, Florida

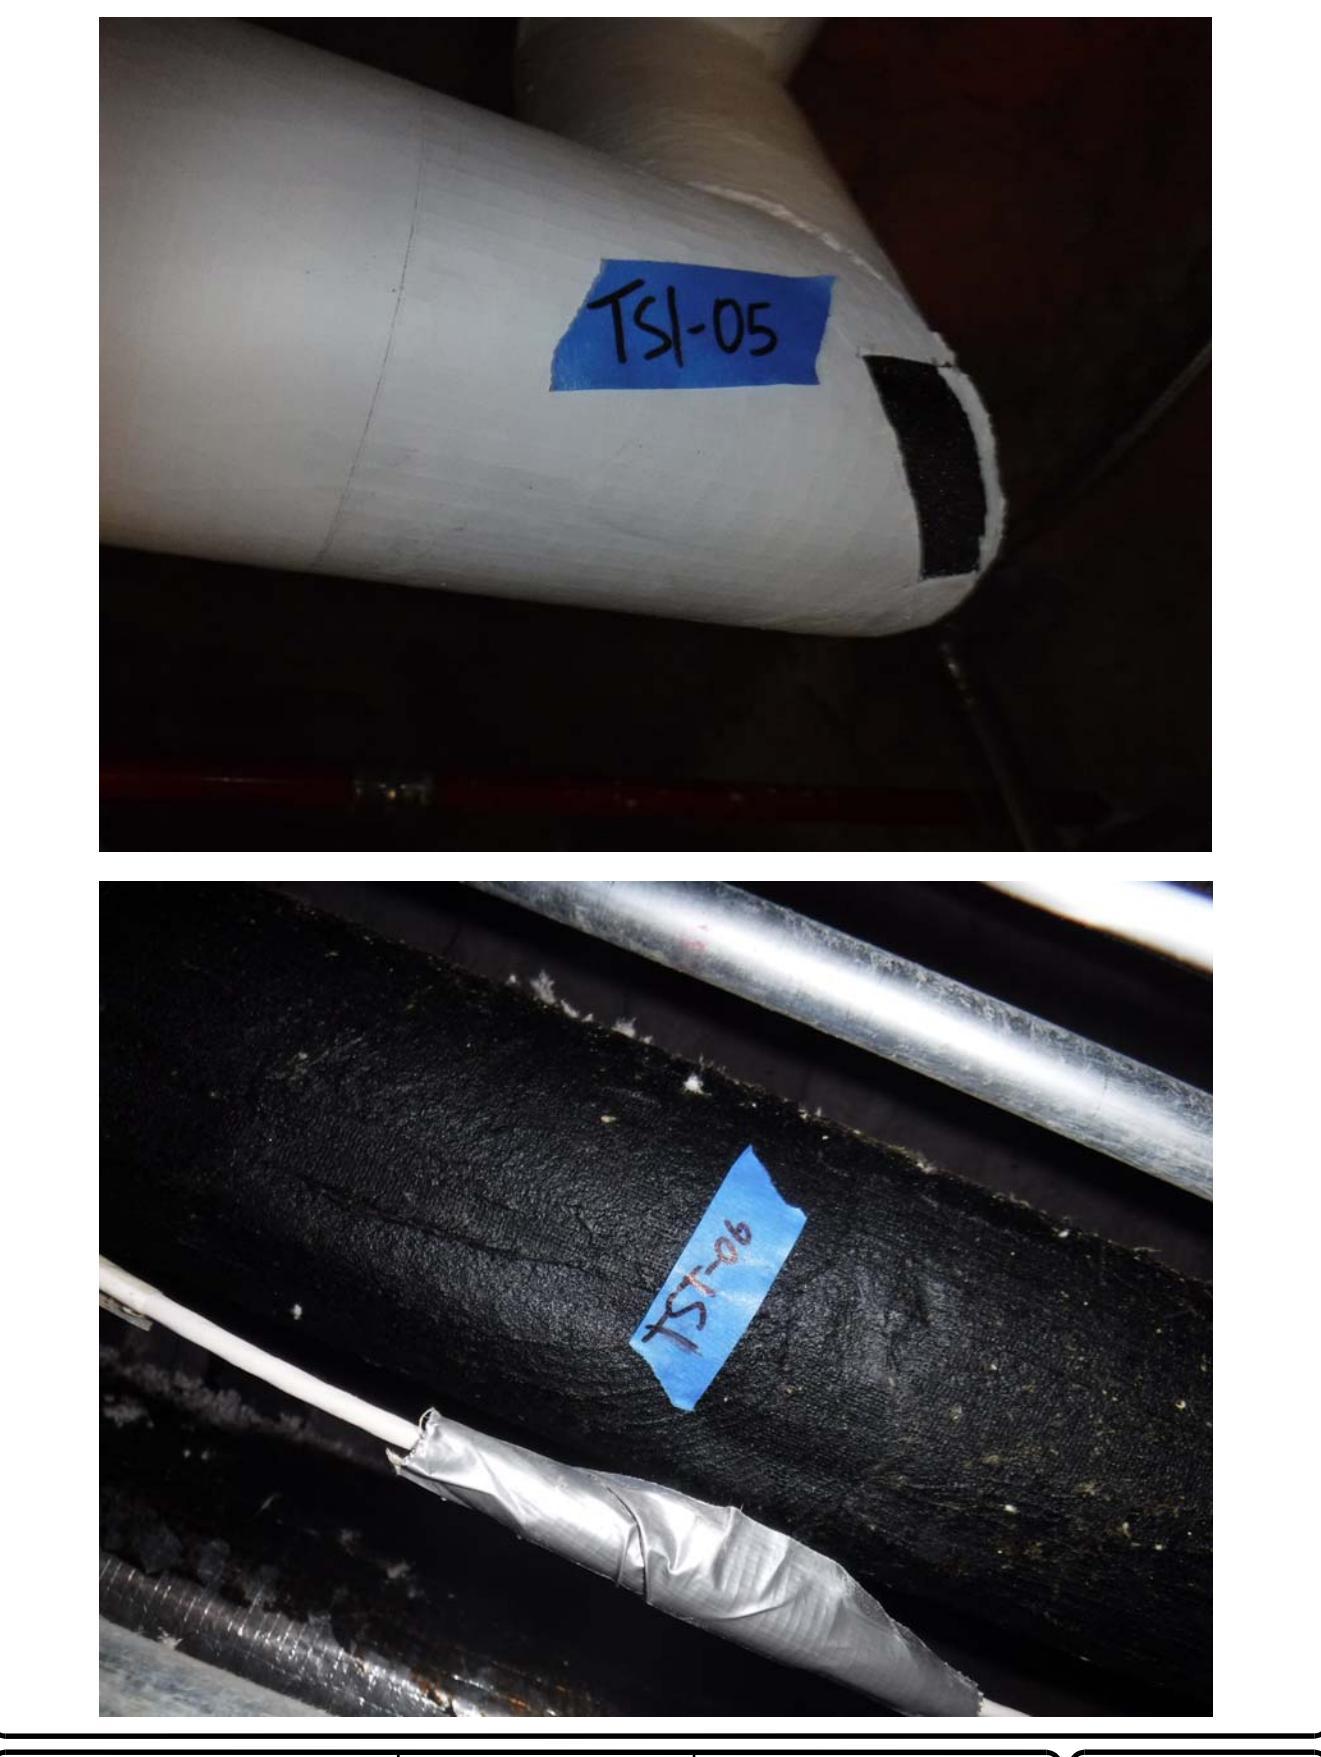
_
UF DSB 8-10 Plenum	
Job No. 19140-01824	
Figure 11	
	_

Upper Photo: TSI-05-White Mastic on Foamglass TSI

Lower Photo: TSI-06-Black Mastic on Foamglass TSI Photograph Date: September 4, 2019

These materials are defined by the EPA as a Category I non-friable materials. These materials do not appear to present a significant issue, as observed, at the time of the survey. We recommend that the identified ACM be maintained as part of an O&M Program and periodically monitored for any changes in condition. Additionally, we recommend that a licensed asbestos abatement contractor properly remove and dispose of the ACM prior to conducting renovation activities that might disturb the ACM.

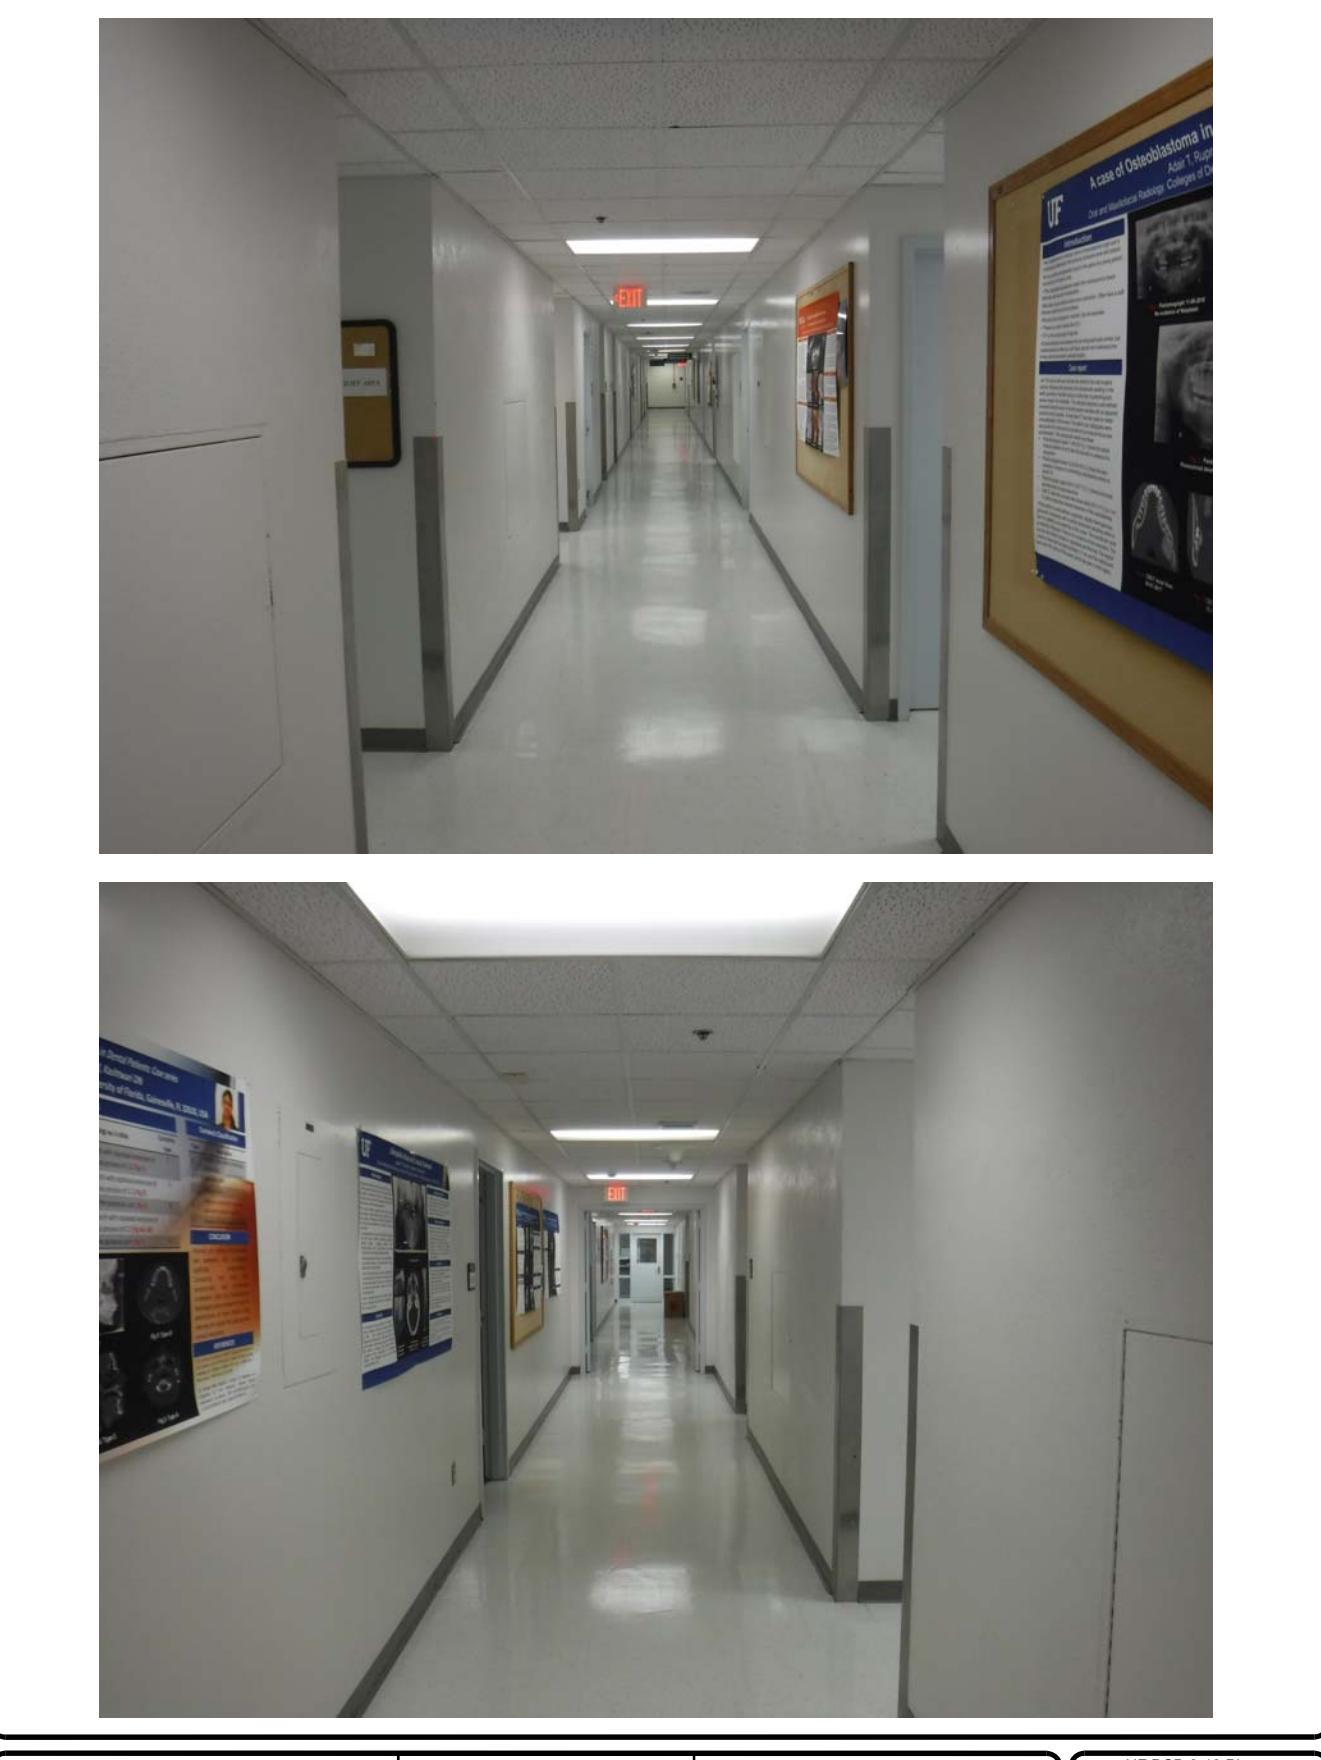
Upper Photo: DSB Floor 8 Hallway North

Lower Photo: DSB Floor 8 Hallway South

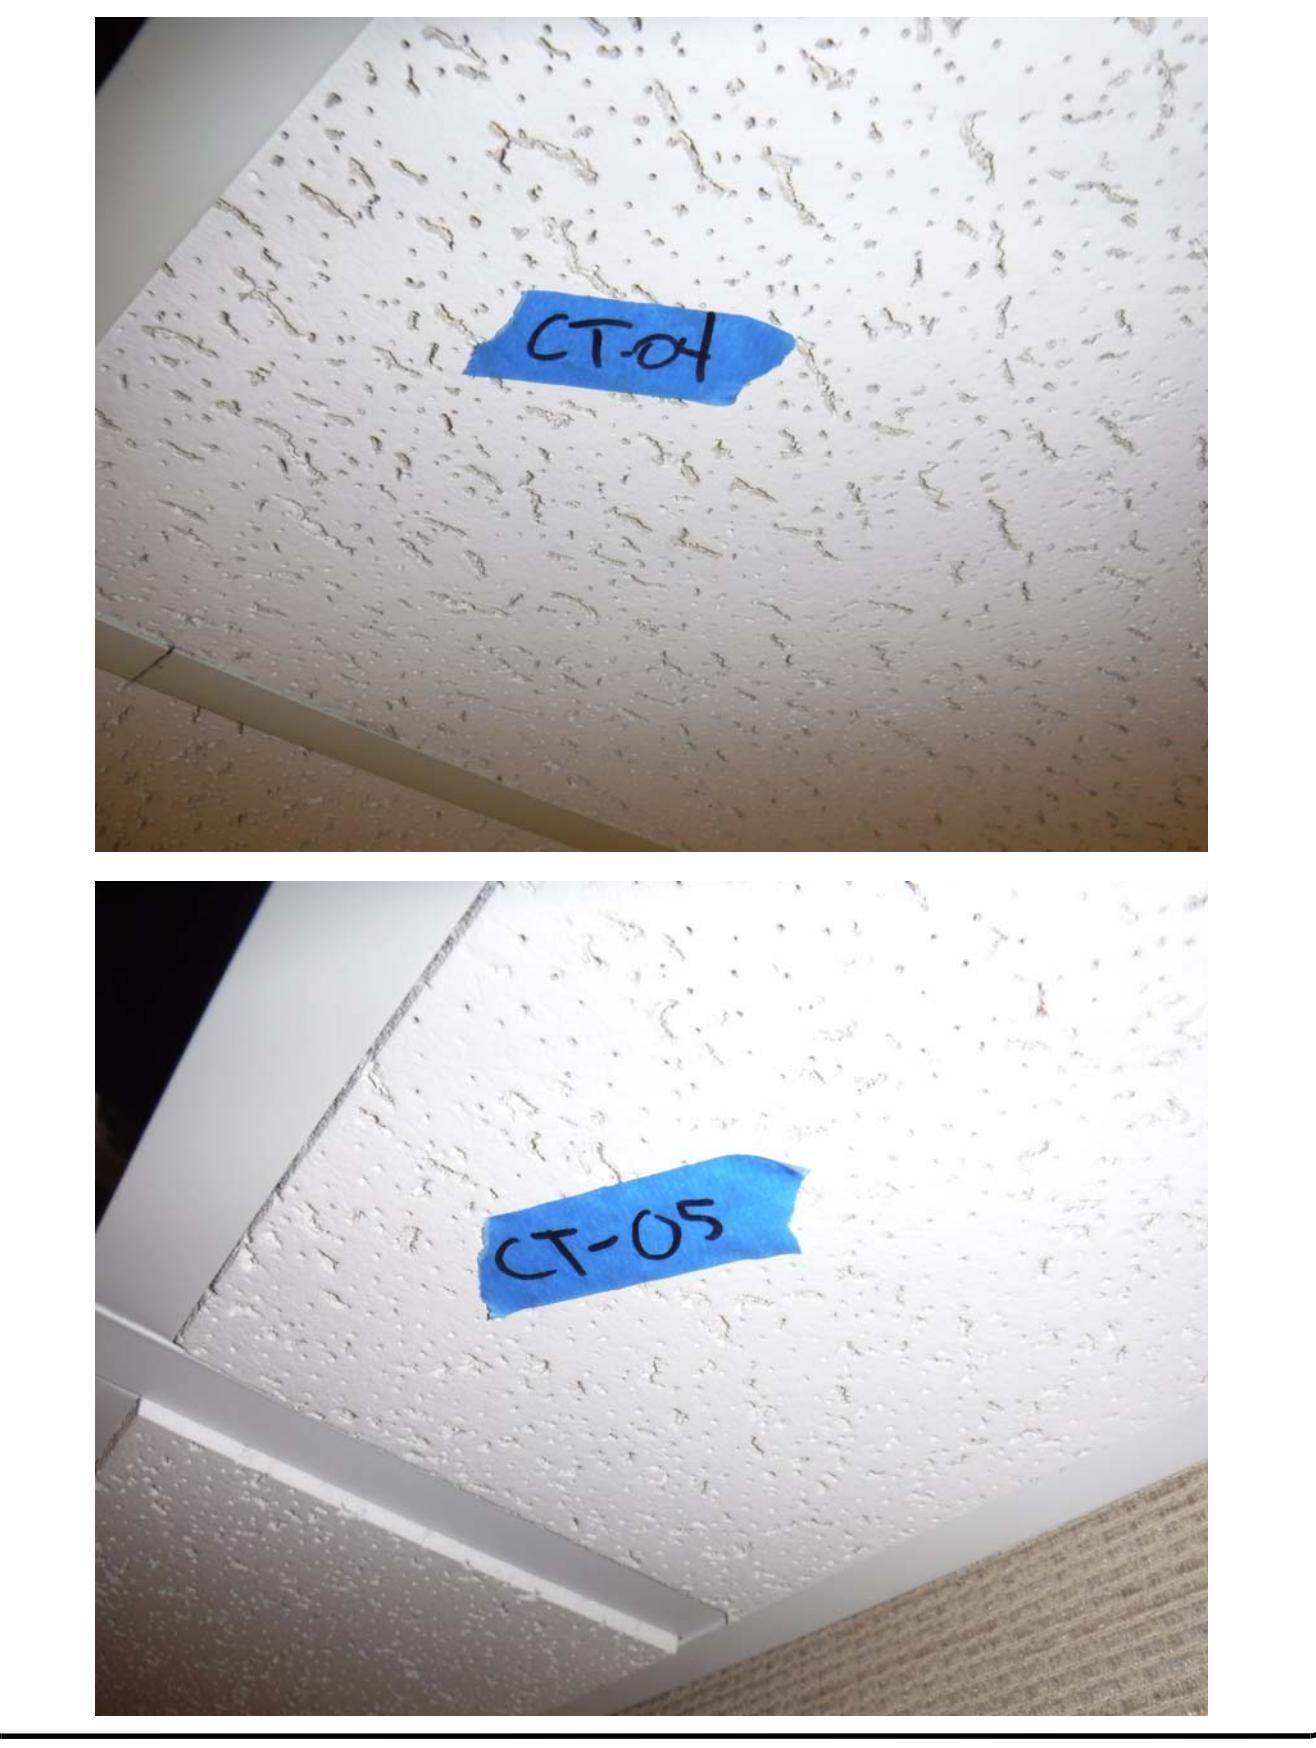
Upper Photo: CT-04-2' x 2' White Fissured Ceiling Tile

Lower Photo: CT-05-2' x 2' White Recessed Ceiling Tile Photograph Date: September 4, 2019

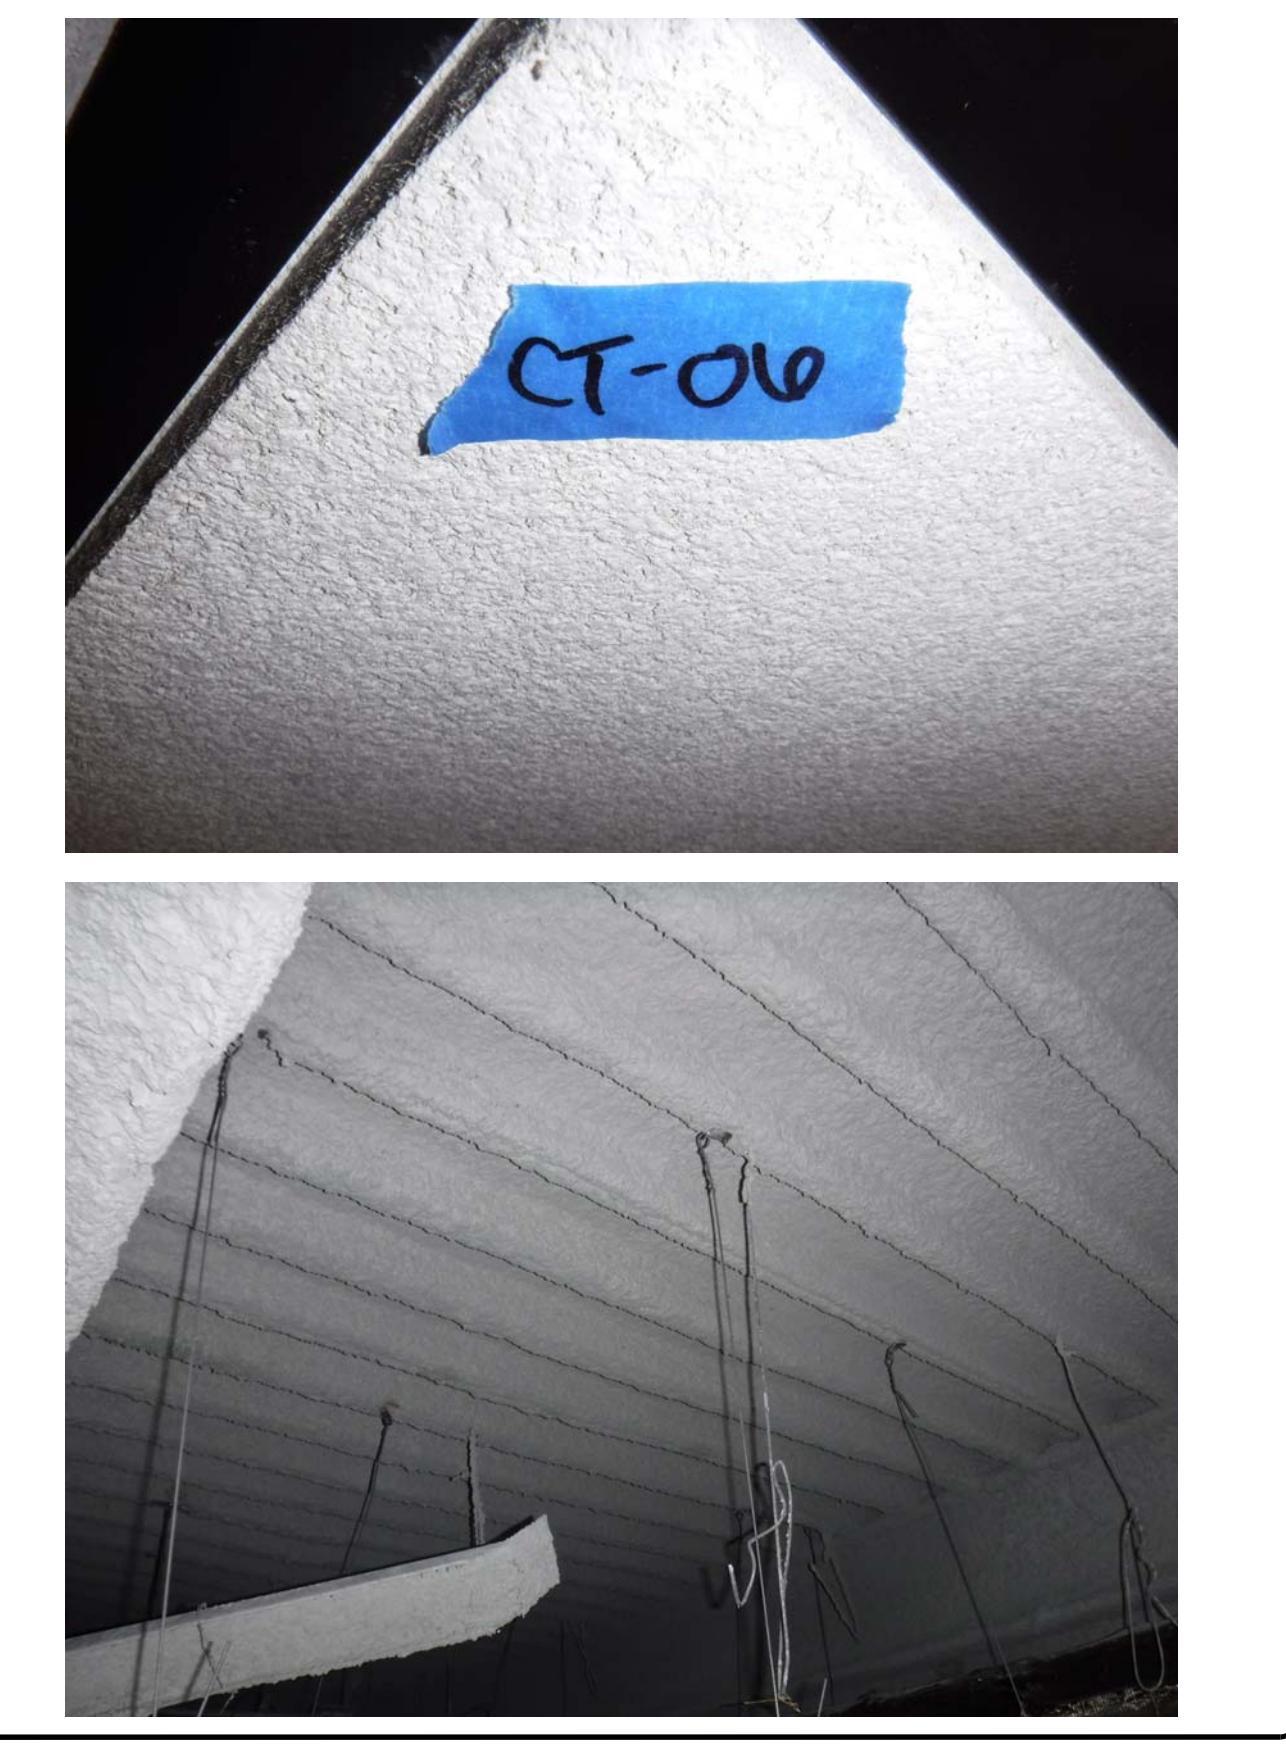
Upper Photo: CT-06- 2' x 2' White Smooth Recessed Ceiling Tile

Lower Photo: FP-04-Tan Fireproofing

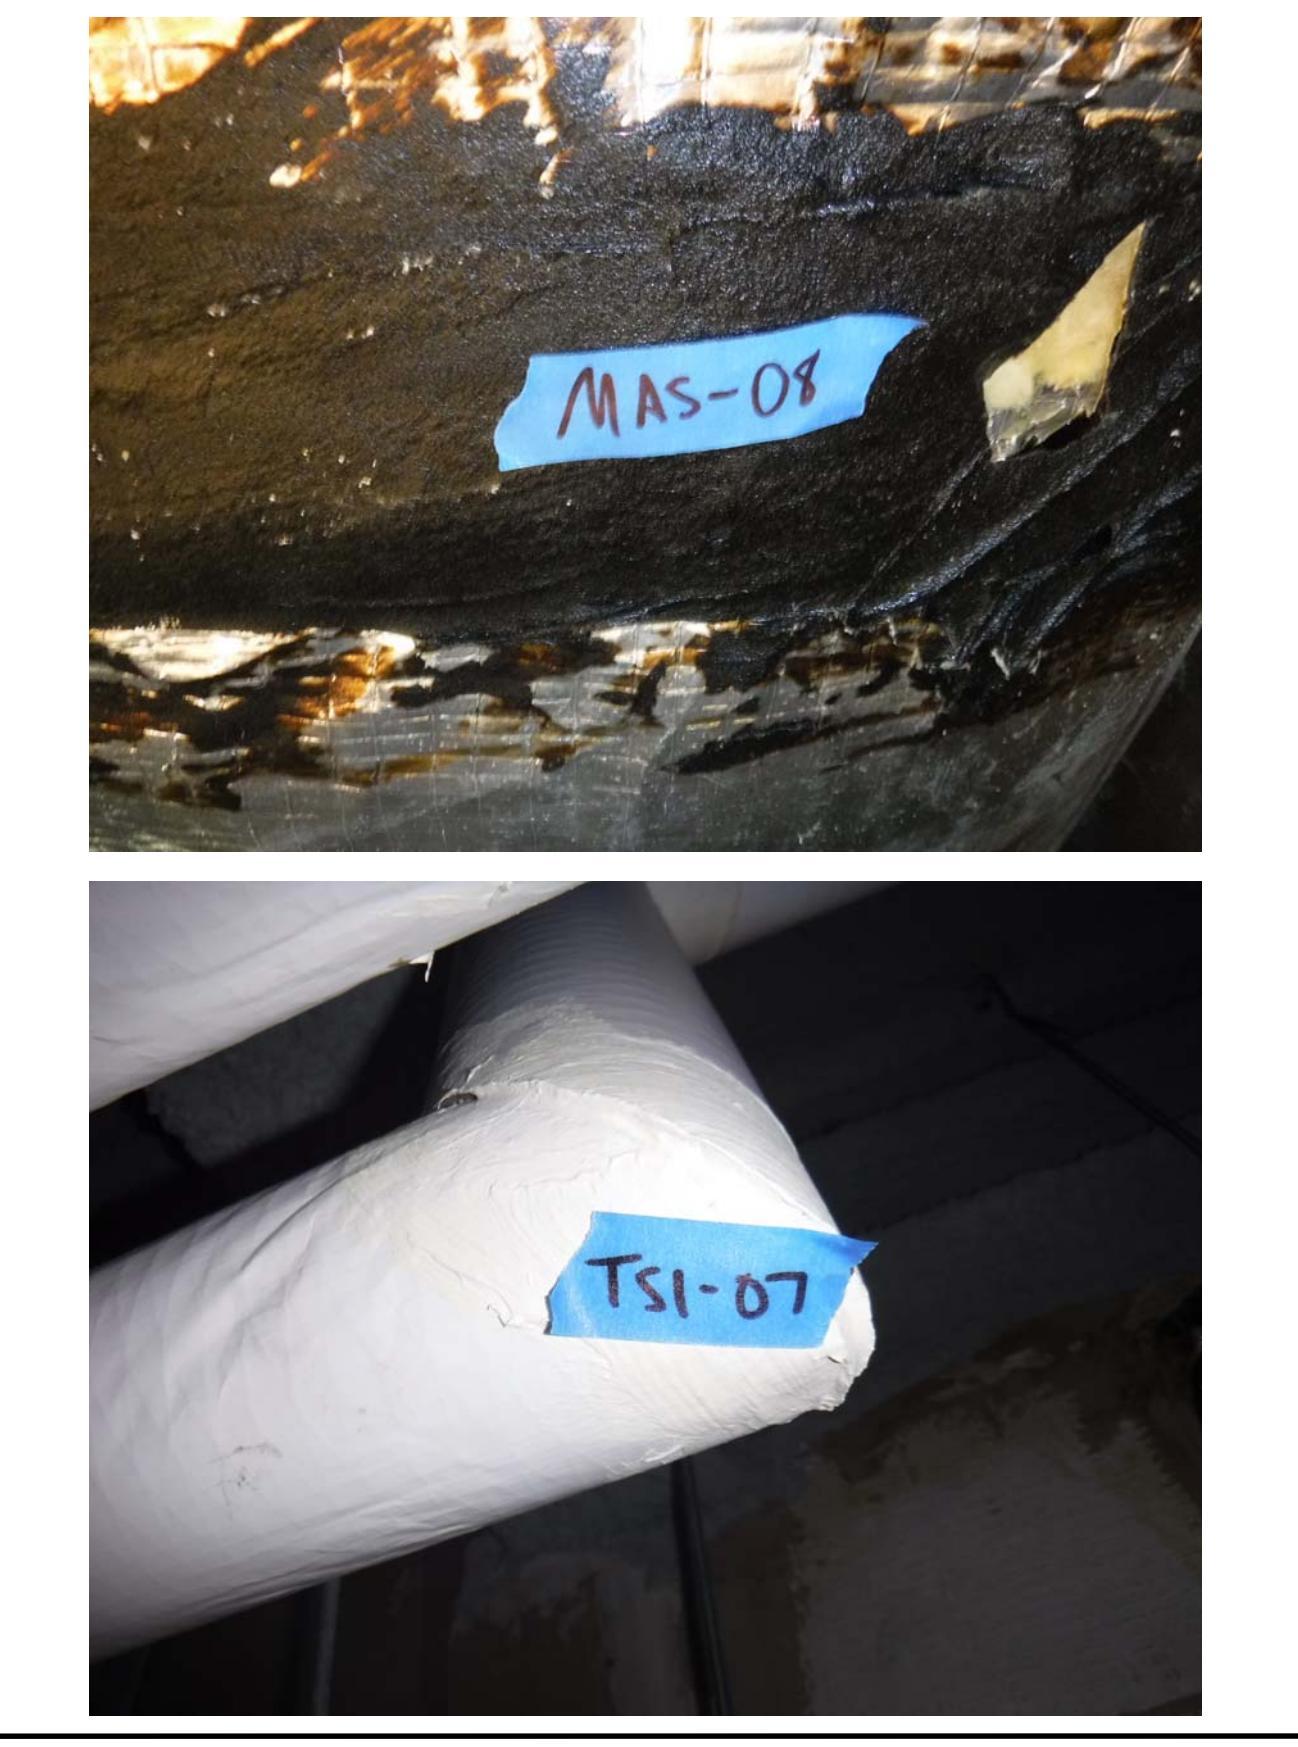
Upper Photo: MAS-08-Black Duct Mastic Photograph Date: September 4, 2019

Lower Photo: TSI-07-White Mastic on Fiberglass TSI

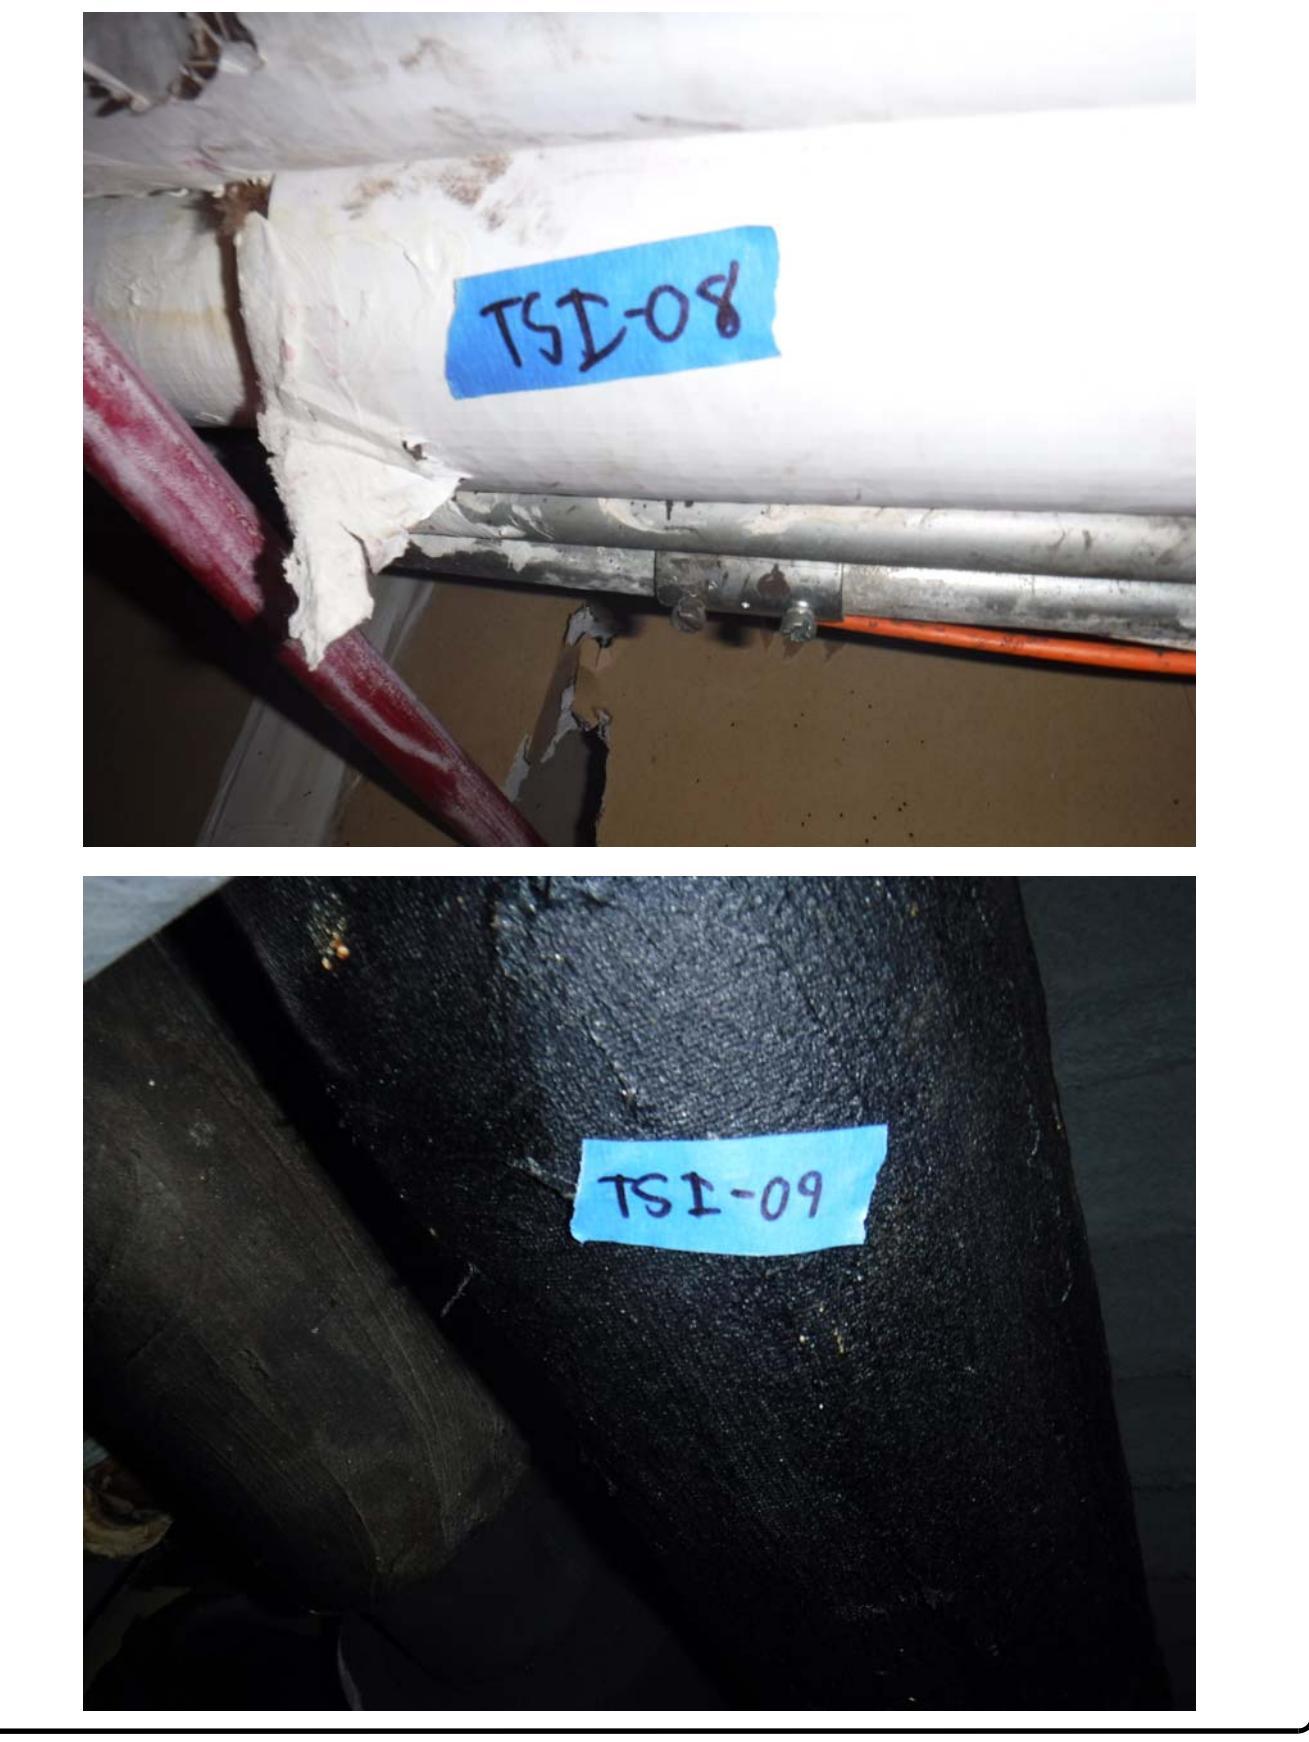
Upper Photo: TSI-08-White Mastic on Foamglass TSI

Lower Photo: TSI-09-Black Mastic on Foamglass TSI Photograph Date: September 4, 2019
